WETLAND DETERMINATION DATA FORM - North Central and Northeast Region

Project/Site: SPP	City/County: Cas	City/County: Cass		Sampling Date: 2016-08-04	
Applicant/Owner: Enbridge		State: Minnesota	Sampli	ng Point: <u>u-139n25w5-aa1</u>	
Investigator(s): DPT, MGH	Section, To	ownship, Range: S5, T139N	, R25W		
Landform (hillslope, terrace, etc.): Rise	2	Local Relief (concav	re, convex, none): VL	Slope (%): 0-2%	
Subregion (LRR or MLRA):	 Latitı	ude: 46.8759583170	Longitude: -93.86402509	Datum: NAD83	
Soil Map Unit Name: 540			NWI Cla	ssification: N/A	
Are climatic/hydrologic conditions on	the site typical for this time	of year? (if no, explain in Re		Yes	
Are Vegetation No , Soil No , or I			,		
Are Vegetation No , Soil No , or Hy				-	
SUMMARY OF FINDINGS - Attach s	ite map showing sampling p	ooint locations, transects, in	mportant features, etc.		
Hydrophytic Vegetation Present?	<u>No</u>	Is the Sampled Area	a		
Hydric Soil Present?	No	within a Wetland?		<u>No</u>	
Wetland Hydrology Present?	<u>No</u>	If yes, optional Wet	land Site ID:

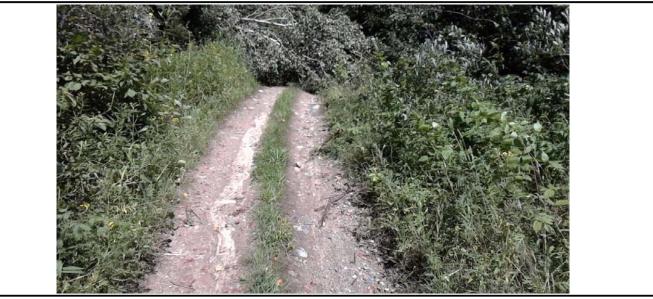
Site Photograph 1 Sampling Point: u-139n25w5-aa1

Latitude: 46.8759690458392	Cowardin Classification:			
Longitude: -93.8640052267293	Circular 39:			
Direction: east	Eggers & Reed:			
Remarks:				
Upland

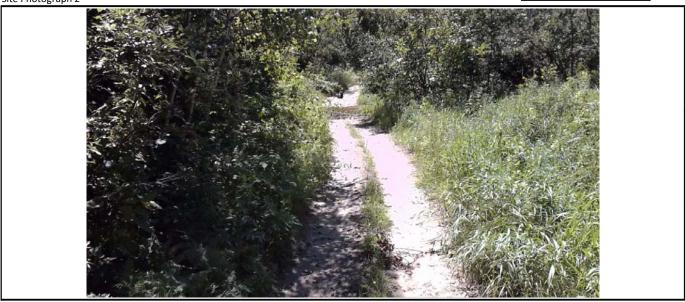
Site Photograph 2 Sampling Point: u-139n25w5-aa1

ALAN, STORY	A STATE OF THE STA
Latitude: 46.8759736558859	Cowardin Classification:
Longitude: -93.8639943302552	Circular 39:
Direction: west	Eggers & Reed:
Remarks: Upland	
I .
