WETLAND DETERMINATION DATA FORM - North Central and Northeast Region

Project/Site: SPP	City/Count	City/County: Cass Sampling Date: 2016-07-29		ng Date: 2016-07-29	
Applicant/Owner: Enbridge		State: Minneso	ota Sampli	ng Point: u-139n25w7-NWI	
Investigator(s): DPT, MGH	Sect	ion, Township, Range: S18, T	139N, S25W		
Landform (hillslope, terrace, etc.): Ris	e	Local Relief (co	ncave, convex, none): VL	Slope (%): <u>0-2%</u>	
Subregion (LRR or MLRA):		Latitude: 46.8626527162	Longitude: -93.90014497	Datum: NAD83	
Soil Map Unit Name: 142			NWI Cla	assification: PFO/SSB	
Are climatic/hydrologic conditions on	the site typical for this	time of year? (if no, explain	in Remarks):	Yes	
Are Vegetation No_, Soil No_, or	Hydrology No_signific	cantly disturbed? Are "Norm	nal Circumstances" present? Yes	-	
Are Vegetation No_, Soil No_, or H	ydrology No naturally	y problematic? (If needed, e	xplain any answers in Remarks)		
SUMMARY OF FINDINGS - Attach	site map showing sam	oling point locations, transec	cts, important features, etc.

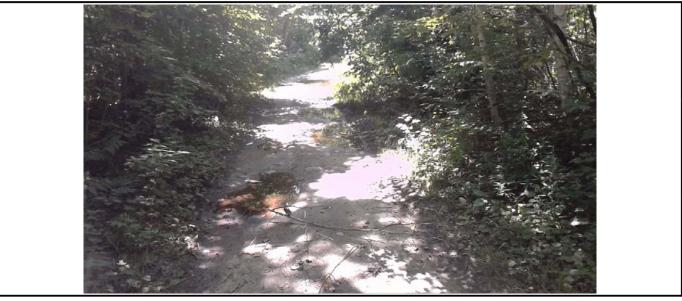
Site Photograph 1 Sampling Point: u-139n25w7-NWI

Latitude: 46.8626361201022	Cowardin Classification:				
Longitude: -93.9001405333112	Circular 39:				
Direction: south	Eggers & Reed:				
Remarks:					
upland
