WETLAND DETERMINATION DATA FORM - North Central and Northeast Region

Site Photograph 1 Sampling Point: u-139n25w8-ak1

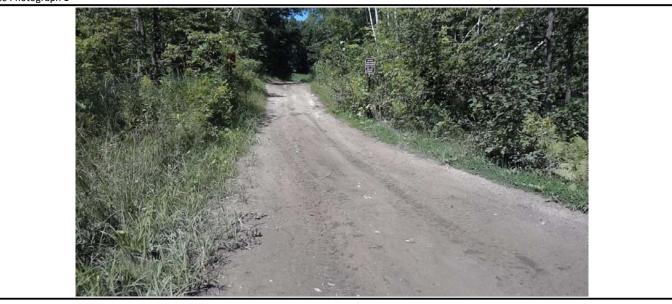
Latitude: 46.8637937866588	Cowardin Classification:
Longitude: -93.8783584815393	Circular 39:
Direction: north	Eggers & Reed:
Remarks:	
Upland

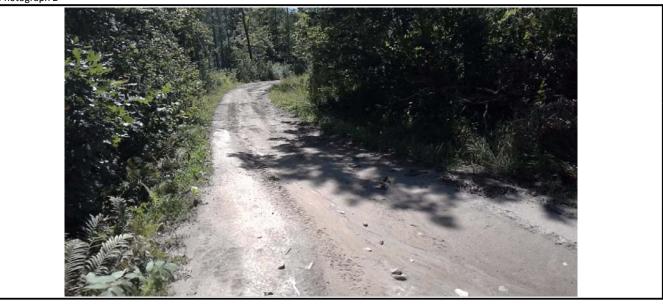
Site Photograph 2 Sampling Point: u-139n25w8-ak1

Latitude: 46.8638084549893	Cowardin Classification:			
Longitude: -93.8783493452648	Circular 39:			
Direction: south	Eggers & Reed:			
Remarks:				
Upland
