## WETLAND DETERMINATION DATA FORM - North Central and Northeast Region

Project/Site: SPP	City/County: Cas	City/County: Cass		Sampling Date: 2016-08-04	
Applicant/Owner: Enbridge		State: Minnesota		ng Point: <u>u-139n25w8-as1</u>	
Investigator(s): DPT, MGH	Section, T	ownship, Range: S8, T139N	N, R25W		
Landform (hillslope, terrace, etc.): Rise	<u>,                                      </u>	Local Relief (conca	ve, convex, none): VL	Slope (%): 0-2%	
Subregion (LRR or MLRA):	 Latit	ude: 46.8709688215	Longitude: -93.86941708	Datum: NAD83	
Soil Map Unit Name: 142			NWI Cla	assification: N/A	
Are climatic/hydrologic conditions on the site typical for this time of year? (if no, explain in Rei				Yes	
Are Vegetation No , Soil No , or H		, , , ,	,		
Are Vegetation No_, Soil No_, or Hy	drology No naturally prob	olematic? (If needed, expla	ain any answers in Remarks)		
SUMMARY OF FINDINGS - Attach s	ite map showing sampling	point locations, transects,	important features, etc.		
Hydrophytic Vegetation Present?	<u>No</u>	Is the Sampled Are	ea

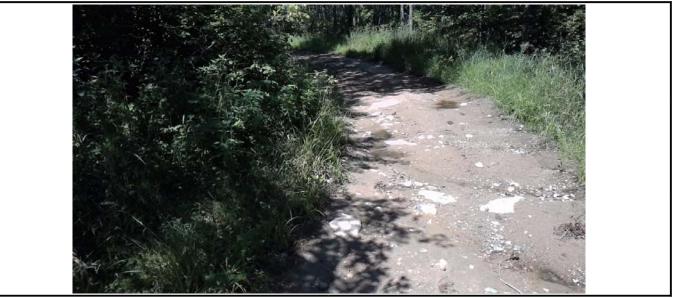
Site Photograph 1 Sampling Point: u-139n25w8-as1

Latitude: 46.8682284001697	Cowardin Classification:			
Longitude: -93.8702991140018	Circular 39:			
Direction: west	Eggers & Reed:			
Remarks:				
Upland

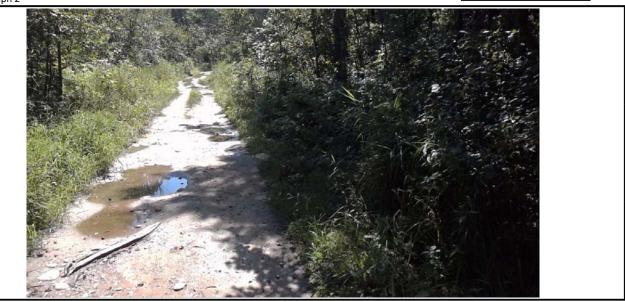
Site Photograph 2 Sampling Point: u-139n25w8-as1

Latitude: 46.8683833396499	Cowardin Classification:			
Longitude: -93.8704545983056	Circular 39:			
Direction: east	Eggers & Reed:			
Remarks:				
Upland
