WETLAND DETERMINATION DATA FORM - North Central and Northeast Region

Project/Site: SPP	City/County: Ca	ass	Sampl	ing Date: 2016-08-04	
Applicant/Owner: Enbridge		State: Minnesota	Sampli	ng Point: <u>u-139n25w8-aw1</u>	
Investigator(s): DPT, MGH	Section, ´	Township, Range: S8, T139	N, R25W		
Landform (hillslope, terrace, etc.): Rise	<u>, </u>	Local Relief (conca	ive, convex, none): VL	Slope (%): 0-2%	
Subregion (LRR or MLRA):	 Lati	itude: 46.8707059650	Longitude: -93.86344271	Datum: NAD83	
Soil Map Unit Name: 144B			-	assification: N/A	
Are climatic/hydrologic conditions on	the site typical for this time	e of vear? (if no. explain in P		Yes	
Are Vegetation No , Soil No , or H			•		
Are Vegetation No_, Soil No_, or Hy	drology No naturally pro	oblematic? (If needed, expl	ain any answers in Remarks)		
SUMMARY OF FINDINGS - Attach s	ite map showing sampling	point locations, transects,	important features, etc.		
Hydrophytic Vegetation Present?	<u>No</u>	Is the Sampled Are	ea

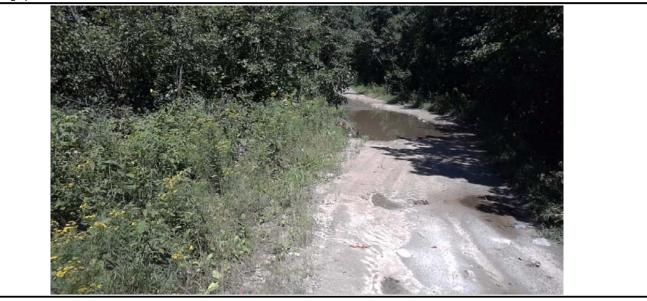
Site Photograph 1 Sampling Point: u-139n25w8-aw1

The second of th	
Latitude: 46.8707029056241	Cowardin Classification:
Longitude: -93.8634565473477	Circular 39:
Direction: north	Eggers & Reed:
Remarks:	
Upland	
1

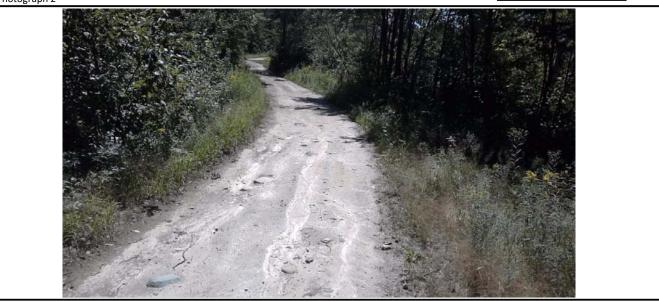
Site Photograph 2 Sampling Point: u-139n25w8-aw1

Latitude: 46.8707794743095	Cowardin Classification:
Longitude: -93.863449338911	Circular 39:
ection: south	Eggers & Reed:
marks:	
land
