WETLAND DETERMINATION DATA FORM - North Central and Northeast Region

Site Photograph 1 Sampling Point: w-138n32w7-aa1

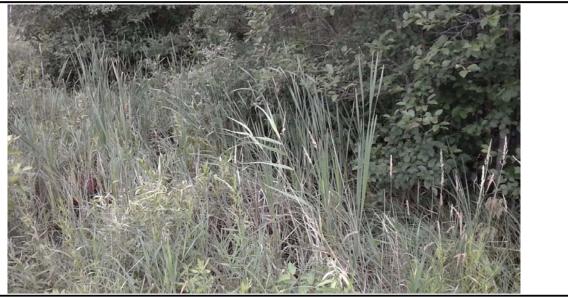
A SANTANA AND A				
Latitude:	46.7892995803121	Cowardin Classification: PEM		
Longitude:	-94.7661300190676	Circular 39: 2		
Direction: sout	th	Eggers & Reed: Fresh (Wet) Meadow		
Remarks:

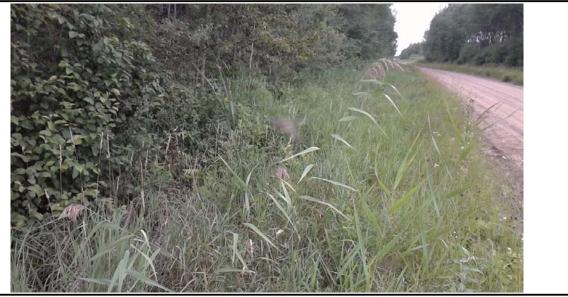
Site Photograph 2 Sampling Point: w-138n32w7-aa1

Latitude: 46.7892984906647	Cowardin Classification: PEM			
Longitude: -94.7661340423811	Circular 39: 2			
Direction: west	Eggers & Reed: Fresh (Wet) Meadow			
Remarks:
