WETLAND DETERMINATION DATA FORM - North Central and Northeast Region

| Project/Site: SPP | _ Ci | City/County: Cass | | Sampling Date: 2016-07-26 | |
| Applicant/Owner: Enbridge | | | State: Minnesota | Samplir | ng Point: w-138n32w8-aa1 |

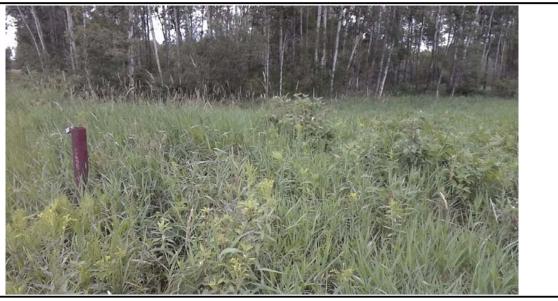
Site Photograph 1 Sampling Point: w-138n32w8-aa1

| Latitude: 46.7893870454717 | Cowardin Classification: PEM | |
| Longitude: -94.765658117919 | Circular 39: 2 | |
| Direction: east | Eggers & Reed: Fresh (Wet) Meadow | |

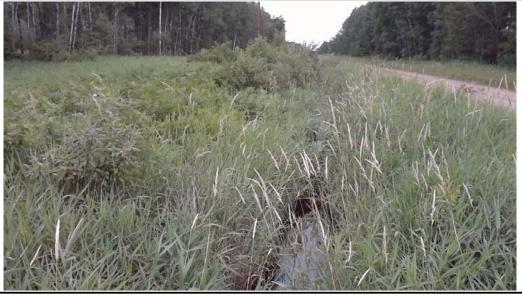
Site Photograph 2 Sampling Point: w-138n32w8-aa1

| Latitude: 46.7893863749195 | Cowardin Classification: PEM | |
| Longitude: -94.7656618059564 | Circular 39: 2 | |
| Direction: south | Eggers & Reed: Fresh (Wet) Meadow | |
