## WETLAND DETERMINATION DATA FORM - North Central and Northeast Region

Site Photograph 1 Sampling Point: w-139n25w18-aa1

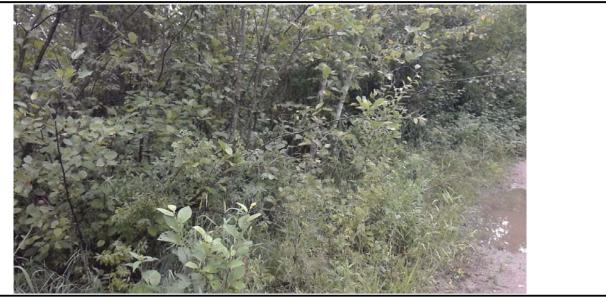
Latitude: 46.84796812	Cowardin Classification: PSS	
Longitude: -93.88963059	Circular 39: 6	
Direction: south	Eggers & Reed: Shrub-Carr/Alder Thicket	
Remarks:
