WETLAND DETERMINATION DATA FORM - North Central and Northeast Region

Project/Site: SPP	City/County: Cass		Sampling Date: 2016-07-27	
Applicant/Owner: Enbridge	State: Minnesota Sampling Point: w-139n25w18-ab1			g Point: w-139n25w18-ab1
Investigator(s): DPT, MGH	Section, Townshi	p, Range: S18, T139N, R25		
Landform (hillslope, terrace, etc.): Depression	Local Relief (concave, convex, none): CL Slope (%): 0-2%			
Subregion (LRR or MLRA):	 Latitude: 46	•	tude: -93.88981033	Datum: NAD83
Soil Map Unit Name: 218				sification: N/A
Are climatic/hydrologic conditions on the site ty	nical for this time of year	? (if no explain in Remarks		Yes

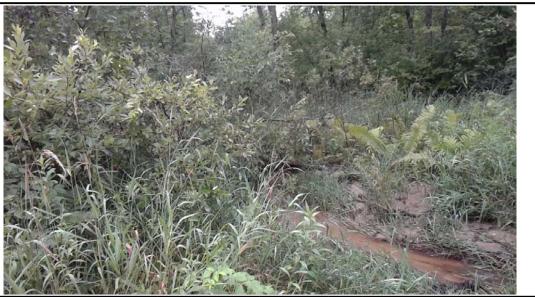
Site Photograph 1 Sampling Point: w-139n25w18-ab1

Latitude: 46.84800712	Cowardin Classification: PSS	
Longitude: -93.88981033	Circular 39: 6	
Direction: west	Eggers & Reed: Shrub-Carr/Alder Thicket	
Remarks:		
l .

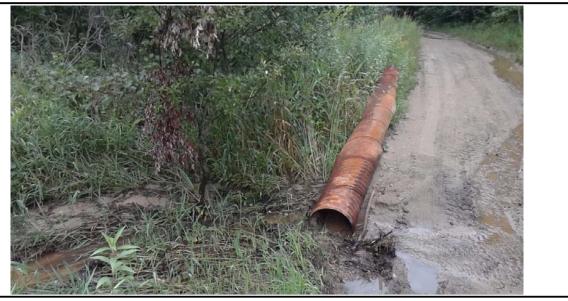
Site Photograph 2 Sampling Point: w-139n25w18-ab1

Latitude:	46.84800712	Cowardin Classification: PSS
Longitude:	-93.88981033	Circular 39: 6
Direction: nort	<u>th</u>	Eggers & Reed: Shrub-Carr/Alder Thicket
Remarks:
