WETLAND DETERMINATION DATA FORM - North Central and Northeast Region

| Project/Site: SPP | City/County: Cass | | Sampling Date: 2016-07-29 | | | |
| Applicant/Owner: Enbridge | | State: Minnesota | Sampling Point: w-139n25w18-ac1 | | | |

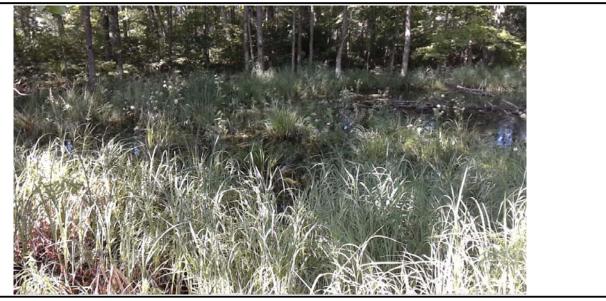
Site Photograph 1 Sampling Point: w-139n25w18-ac1

| Latitude: | 46.8529650802229 | Cowardin Classification: PEM |
| Longitude: | -93.8989499677847 | Circular 39: 1 |
| Direction: west | <u>t</u> | Eggers & Reed: Seasonally Flooded Basin |

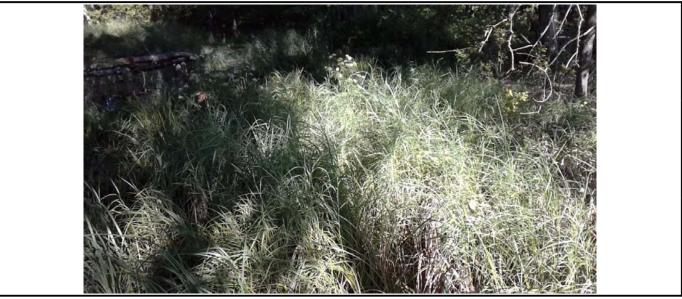
Site Photograph 2 Sampling Point: w-139n25w18-ac1

| Latitude: 46.8529680557985 | Cowardin Classification: PEM | | |
| Longitude: -93.898950805975 | Circular 39: 1 | | |
| Direction: north | Eggers & Reed: Seasonally Flooded Basin | | |
