WETLAND DETERMINATION DATA FORM - North Central and Northeast Region

Project/Site: SPP	City/County: Cass		Sampling Date: 2016-07-29		
Applicant/Owner: Enbridge		State: Minnesota	Sampling Point: w-139n25w18-ad1		
Investigator(s): DPT, MGH	Section, Townshi	p, Range: S18, T139N, R25W			
Landform (hillslope, terrace, etc.): Depression	n	Local Relief (concave, convex,	none): CL Slope (%): 0-2%		
Subregion (LRR or MLRA):	 Latitude: 46	5.8560234690 Longitude	2: -93.90071846 Datum: NAD83		
Soil Map Unit Name: 540	<u> </u>		NWI Classification: PUBH		
Are climatic/hydrologic conditions on the sit	e typical for this time of year	? (if no, explain in Remarks):	Yes		
Are Vegetation No , Soil No , or Hydrol	logy No significantly distur	ped? Are "Normal Circumstanc	es" present? Yes		
Are Vegetation No_, Soil No_, or Hydrology No_ naturally problematic? (If needed, explain any answers in Remarks)					
SUMMARY OF FINDINGS - Attach site ma	ap showing sampling point lo	cations, transects, important f	reatures, etc.

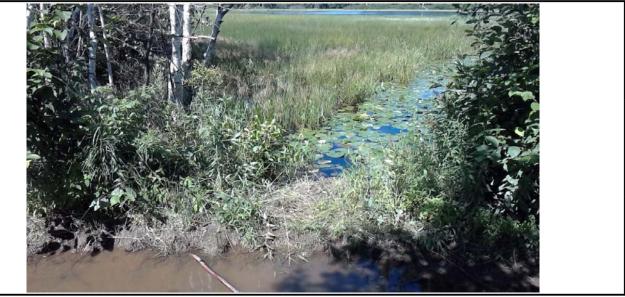
Site Photograph 1 Sampling Point: w-139n25w18-ad1

THE RESERVE TO THE PERSON NAMED IN COLUMN TWO IS NOT THE PERSON NAMED IN COLUMN TWO IS NOT THE PERSON NAMED IN	
Latitude: 46.8560204934765	Cowardin Classification: PEM
Longitude: -93.9007193037252	Circular 39: 4
Direction: west	Eggers & Reed: Deep Marsh
Remarks:

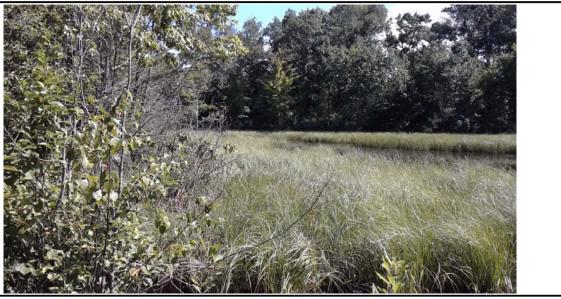
Site Photograph 2 Sampling Point: w-139n25w18-ad1

Latitude:	46.856020451567	Cowardin Classification: PEM
Longitude:	-93.9007201419155	Circular 39: 4
Direction: nort	th	Eggers & Reed: Deep Marsh
Remarks:		
1
