## WETLAND DETERMINATION DATA FORM - North Central and Northeast Region

Project/Site: SPP	City/County: Cass		Sampling Date: 2016-08-02				
Applicant/Owner: Enbridge		State: Minnesota	Sampling Point: w-139n25w18-ag2				
Investigator(s): DPT, MGH	Investigator(s): DPT, MGH Section, Township, Range: S18, T139N, R25W						
Landform (hillslope, terrace, etc.): Depressio	n	Local Relief (concave, convex	s, none): CC Slope (%): 0-2%				
Subregion (LRR or MLRA):	 Latitude: 40	5.8520868663 Longitud	le: -93.88698111 Datum: NAD83				
Soil Map Unit Name: 144B	<u> </u>		NWI Classification: N/A				
Are climatic/hydrologic conditions on the sit	e typical for this time of year	? (if no, explain in Remarks):	Yes				
Are Vegetation No , Soil No , or Hydrol	ogy <u>NO</u> significantly distur	oed? Are "Normal Circumstan	ces" present? Tes				
Are Vegetation No , Soil No , or Hydrolog	gy <u>No</u> naturally problemati	c? (If needed, explain any ans	swers in Remarks)				
SUMMARY OF FINDINGS - Attach site ma	Yes		features, etc.

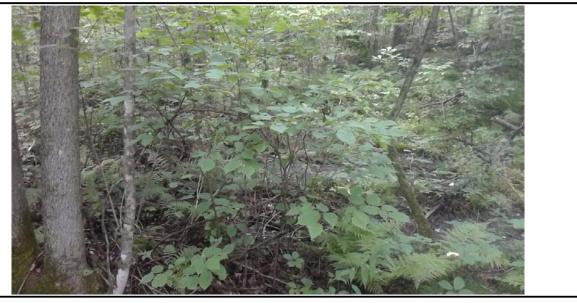
Site Photograph 1 Sampling Point: w-139n25w18-ag2

Latitude:	46.8520893808891	Cowardin Classification: PFO			
Longitude:	-93.8869799395035	Circular 39: 7			
Direction: north		Eggers & Reed: Hardwood Swamp/Coniferous Swamp			
Remarks:

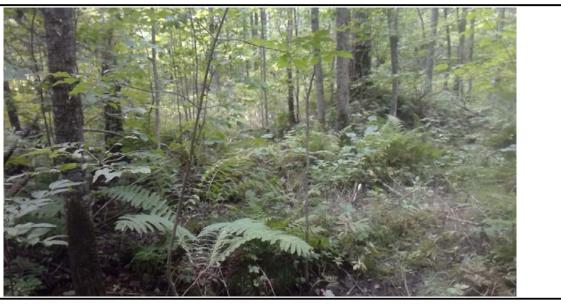
Site Photograph 2 Sampling Point: w-139n25w18-ag2

Latitude:	46.8520894647081	Cowardin	Classification: PFO
Longitude	: -93.8869793527703	Circular 39: 7	
Direction: sou	ıth	Eggers & Reed:	Hardwood Swamp/Coniferous Swamp
Remarks:
