WETLAND DETERMINATION DATA FORM - North Central and Northeast Region

Project/Site: SPP	City/	County: Cass		Sampl	ling Date: 2016-08-02	
Applicant/Owner: Enbridge			State: Minnesota	Sampl	ing Point: w-139n25w18-al1	
Investigator(s): DPT, MGH		Section, Township	o, Range: S18, T139N, R2	25W		
Landform (hillslope, terrace, etc.): Depre	ession		Local Relief (concave, co	onvex, none): CC	Slope (%): 0-2%	
Subregion (LRR or MLRA):		 Latitude: 46	.8611709215 Lon	 ngitude: -93.88123984	. Datum: NAD83	
Soil Map Unit Name: 142		_		NWI CI	assification: N/A	
Are climatic/hydrologic conditions on th	e site typical f	or this time of year	? (if no, explain in Remar	·ks):	Yes	
Are Vegetation No , Soil No , or Hydra Are Vegetation No , Soil No , or Hydra						
SUMMARY OF FINDINGS - Attach sit						
Hydrophytic Vegetation Present?	Ye		Is the Sampled Area	·		
Hydric Soil Present?	Ye	_	within a Wetland?		Yes	
Wetland Hydrology Present?	Ye		If yes, optional Wetland	l Site ID:	w-139n25w18-al

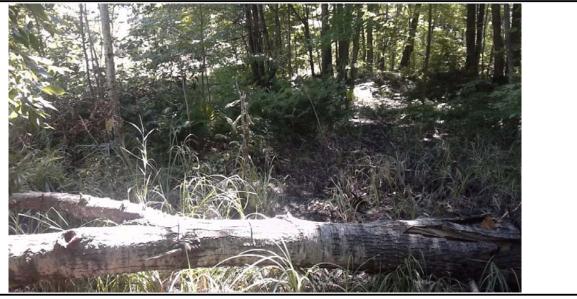
Site Photograph 1 Sampling Point: w-139n25w18-al1

一 一	
Latitude:	46.8611712148849	Cowardin Classification: PEM
Longitude:	-93.8812399283926	Circular 39: 1
Direction: sout	th	Eggers & Reed: Seasonally Flooded Basin
Remarks:

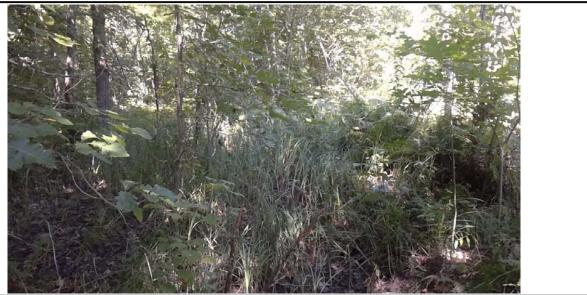
Site Photograph 2 Sampling Point: w-139n25w18-al1

Latitude: 46.8611714244325	Cowardin Classification: PEM
Longitude: -93.8812400122116	Circular 39: 1
Direction: north	Eggers & Reed: Seasonally Flooded Basin
Remarks:
