WETLAND DETERMINATION DATA FORM - North Central and Northeast Region

Project/Site: SPP	C	ity/County: Cass		Sampling Date: 2016-07-27		
Applicant/Owner: Enbridge			State: Minnesota	Samplin	g Point: w-139n25w19-ab1	
Investigator(s): DPT, MGH		Section, Townshi	p, Range: S19, T139N, R2			
Landform (hillslope, terrace, etc.): Depres	sion		Local Relief (concave, co		Slope (%): 0-2%	
Subregion (LRR or MLRA):		 Latitude: 46	•	gitude: -93.88964018	Datum: NAD83	
Soil Map Unit Name: 218				<u> </u>	ssification: N/A	
Are climatic/hydrologic conditions on the	site tynic	al for this time of year	? (if no explain in Remark		Yes	
		·	•		<u></u>	
Are Vegetation No , Soil No , or Hyd	rology <u>No</u>	o significantly disturb	ped? Are "Normal Circum	nstances" present? Yes		
Are Vegetation No_, Soil No_, or Hydro	logy <u>No</u>	_ naturally problemation	c? (If needed, explain an	y answers in Remarks)		
SUMMARY OF FINDINGS - Attach site	map shov	wing sampling point lo	cations, transects, impor	rtant features, etc.

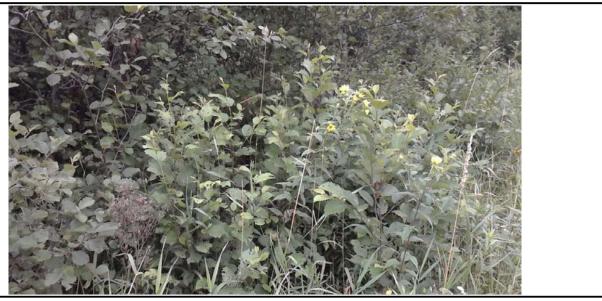
Site Photograph 1 Sampling Point: w-139n25w19-ab1

Latitude: 46.8442247249622	Cowardin Classification: PSS			
Longitude: -93.8896477316449	Circular 39: 6			
Direction: south	Eggers & Reed: Shrub-Carr/Alder Thicket			
Remarks:

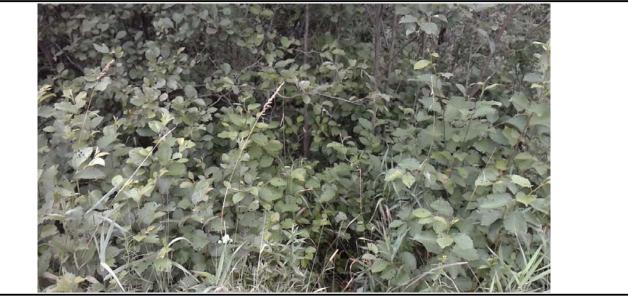
Site Photograph 2 Sampling Point: w-139n25w19-ab1

Latitude:	46.8442225875769	Cowardin Classification: PSS		
Longitude:	-93.8896537666152	Circular 39: <u>6</u>		
Direction: east		Eggers & Reed: Shrub-Carr/Alder Thicket		
Remarks:
