WETLAND DETERMINATION DATA FORM - North Central and Northeast Region

Project/Site: SPP	_ Ci	ty/County: Cass		Sampling Date: 2016-07-27			
Applicant/Owner: Enbridge			State: Minnesota	Samplir	ng Point: w-139n25w19-ac1		
Investigator(s): DPT, MGH		Section, Township, Range: S19, T139N, R25W					
Landform (hillslope, terrace, etc.): Depress	sion	<u> </u>	Local Relief (concave, co		Slope (%): 0-2%		
Subregion (LRR or MLRA):		 Latitude: 46	•	gitude: -93.88663628	Datum: NAD83		
Soil Map Unit Name: 202			2011		ssification: PFO4/2B		
Are climatic/hydrologic conditions on the	site tynic	al for this time of year	? (if no, explain in Remark		Yes		
_		·			1.00		
Are Vegetation No_, Soil No_, or Hyd	rology <u>No</u>	significantly disturb	ped? Are "Normal Circum	nstances" present? Yes			
Are Vegetation No_, Soil No_, or Hydrology No_ naturally problematic? (If needed, explain any answers in Remarks)							
SUMMARY OF FINDINGS - Attach site	map shov	ving sampling point lo	cations, transects, impor	rtant features, etc.

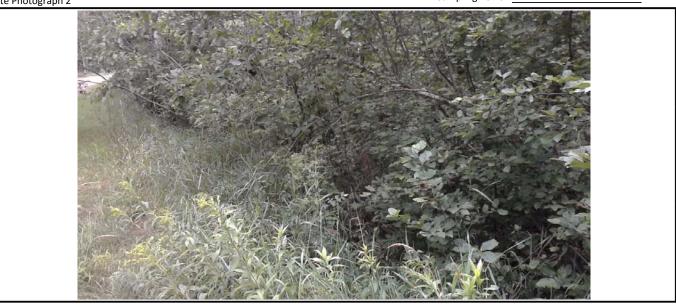
Site Photograph 2 Sampling Point: w-139n25w19-ac1

Latitude:	46.8362563429837	Cowardin Classification: PSS		
Longitude:	-93.8866365329306	Circular 39: 6		
Direction: sout	th	Eggers & Reed: Shrub-Carr/Alder Thicket		
Remarks:
