## WETLAND DETERMINATION DATA FORM - North Central and Northeast Region

Project/Site: SPP	Cit	ty/County: Cass		Sampling Date: 2016-08-03		
Applicant/Owner: Enbridge			State: Minnesota	Samplii	ng Point: <u>w-139n25w4-aa2</u>	
Investigator(s): DPT, MGH		Section, Township	p, Range: <u>S4, T139N, R2</u>	5W		
Landform (hillslope, terrace, etc.): Depre	ession	<u> </u>	Local Relief (concave, co	onvex, none): CC	Slope (%): 0-2%	
Subregion (LRR or MLRA):		Latitude: 46	5.8766010832 Lor	ngitude: -93.84117593	Datum: NAD83	
Soil Map Unit Name: 146B				NWI Cla	ssification: PFO1B	
Are climatic/hydrologic conditions on th	e site typica	al for this time of year	? (if no, explain in Remar	rks):	Yes	
Are Vegetation No , Soil No , or Hy					-	
Are Vegetation No_, Soil No_, or Hydrology No_ naturally problematic? (If needed, explain any answers in Remarks)  SUMMARY OF FINDINGS - Attach site map showing sampling point locations, transects, important features, etc.						
Hydrophytic Vegetation Present?		Yes	Is the Sampled Area

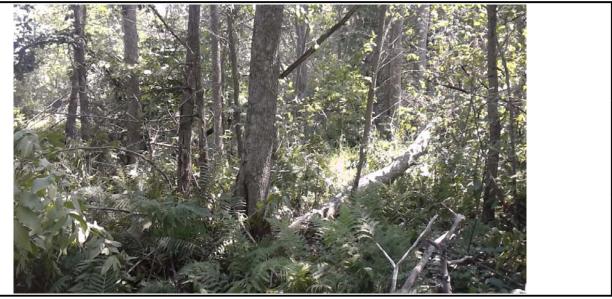
Site Photograph 1 Sampling Point: w-139n25w4-aa2

Latitude: 46.8766007060622	Cowardin Classification: PFO			
Longitude: -93.8411777839939	Circular 39: 7			
Direction: south	Eggers & Reed: Hardwood Swamp/Coniferous Swamp			
Remarks:				
Longitude: -93.8411777839939  Direction: south	Circular 39: 7

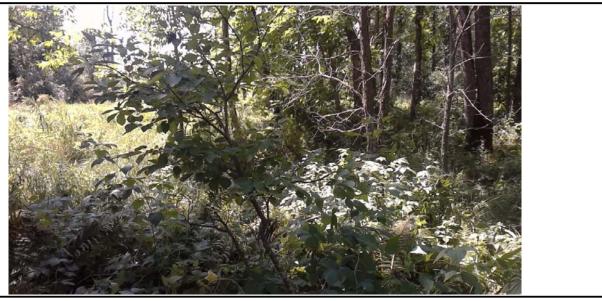
Site Photograph 2 Sampling Point: w-139n25w4-aa2

Latitude: 46.8766012927954	Cowardin Classification: PFO
Longitude: -93.8411783707271	Circular 39: 7
Direction: west	Eggers & Reed: Hardwood Swamp/Coniferous Swamp
Remarks:
