## WETLAND DETERMINATION DATA FORM - North Central and Northeast Region

Project/Site: SPP	Cit	ty/County: Cass		Sampling Date: 2016-08-02			
Applicant/Owner: Enbridge			State: Minnesota	Samplir	ng Point: <u>w-139n25w8-am1</u>		
Investigator(s): DPT, MGH		Section, Township	p, Range: S8, T139N, R25	5W			
Landform (hillslope, terrace, etc.): Depres	sion		Local Relief (concave, co	nvex, none): CC	Slope (%): 0-2%		
Subregion (LRR or MLRA):		 Latitude: 46	5.8611940974 Lon	gitude: -93.88098612	Datum: NAD83		
Soil Map Unit Name: 142				NWI Cla	ssification: N/A		
Are climatic/hydrologic conditions on the	site typica	al for this time of year	? (if no, explain in Remarl	ks):	Yes		
Are Vegetation No , Soil No , or Hyd		<del></del>					
Are Vegetation No_, Soil No_, or Hydrology No_ naturally problematic? (If needed, explain any answers in Remarks)							
SUMMARY OF FINDINGS - Attach site			<u> </u>	rtant features, etc.			
Hydrophytic Vegetation Present?		Yes	Is the Sampled Area

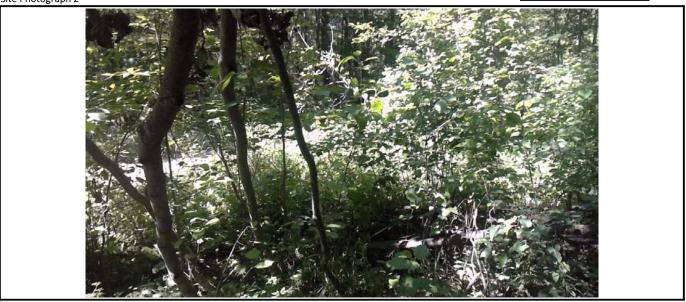
Site Photograph 2 Sampling Point: w-139n25w8-am1

Latitude: 46.861193887933	Cowardin Classification: PSS
Longitude: -93.88098738165	Circular 39: 6
Direction: north	Eggers & Reed: Shrub-Carr/Alder Thicket
Remarks:
