WETLAND DETERMINATION DATA FORM - North Central and Northeast Region

Project/Site: SPP	_ Ci	City/County: Cass		Sampling Date: 2016-08-02			
Applicant/Owner: Enbridge			State: Minnesota	S	Sampling Point: \(\)	w-139n25w8-an1	
Investigator(s): DPT, MGH		Section, Townshi	p, Range: S8, T139N, R25	SW			
Landform (hillslope, terrace, etc.): Depress	ion		Local Relief (concave, co	nvex, none): CC		Slope (%): 0-2%	
Subregion (LRR or MLRA):		Latitude: 46	5.8627687637 Long	gitude: -93.87924	 1847 Datui	m: NAD83	
Soil Map Unit Name: 142					WI Classification		
	site typica	al for this time of year	? (if no. explain in Remark			Yes	
Are climatic/hydrologic conditions on the site typical for this time of year? (if no, explain in Remarks): Are Vegetation No_, Soil No_, or Hydrology No_ significantly disturbed? Are "Normal Circumstances" present? Yes							
Are Vegetation No_, Soil No_, or Hydrology No_ naturally problematic? (If needed, explain any answers in Remarks)							
SUMMARY OF FINDINGS - Attach site n	nap show	ving sampling point lo	cations, transects, impor	rtant features, etc	:.

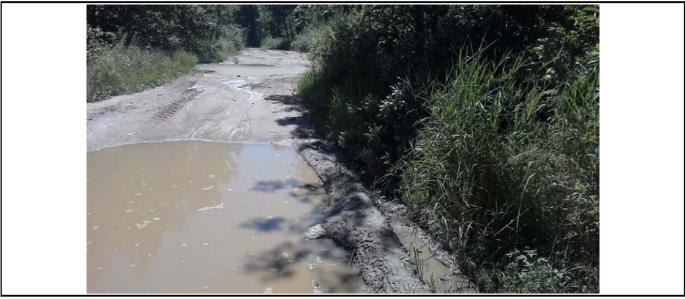
Site Photograph 1 Sampling Point: w-139n25w8-an1

Latitude: 46.8628752138902	Cowardin Classification: PEM
Longitude: -93.8793045469503	Circular 39: 2
Direction: south	Eggers & Reed: Fresh (Wet) Meadow
Remarks:

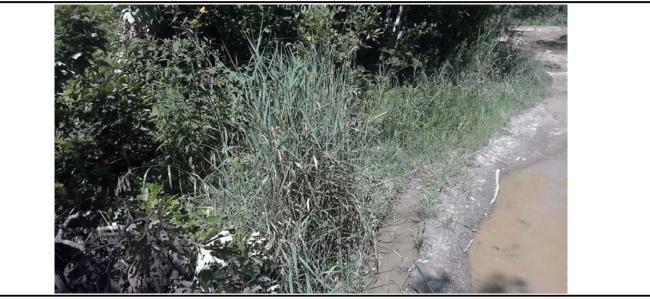
Site Photograph 2 Sampling Point: w-139n25w8-an1

Latitude: 46.8629153212969	Cowardin Classification: PEM
Longitude: -93.8793010265509	Circular 39: 2
Direction: north	Eggers & Reed: Fresh (Wet) Meadow
Demonstra
