## WETLAND DETERMINATION DATA FORM - North Central and Northeast Region

Project/Site: SPP	City/County: Cass		Sampling Date: 2016-08-04		
Applicant/Owner: Enbridge	State: Minnesota		Sampling Point: w-139n25w8-ar1		
Investigator(s): DPT, MGH	Section, Townshi	ip, Range: S8, T139N, R25W	<u></u>		
Landform (hillslope, terrace, etc.): Depression		Local Relief (concave, conv		Slope (%): 0-2%	
Subregion (LRR or MLRA):	Latitude: 4	•	tude: -93.87261612	Datum: NAD83	
Soil Map Unit Name: 142	_			sification: N/A	
Are climatic/hydrologic conditions on the site to	pical for this time of year	? (if no. explain in Remarks		Yes

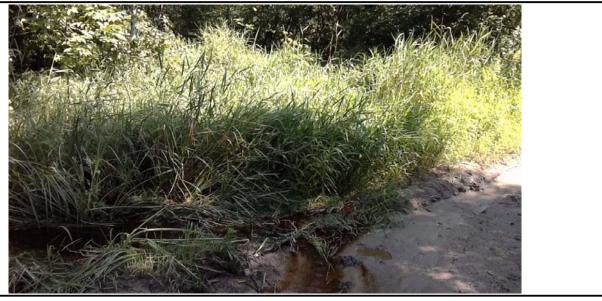
Site Photograph 1 Sampling Point: w-139n25w8-ar1

Latitude: 46.8681767257367	Cowardin Classification: PEM			
Longitude: -93.8726318814735	Circular 39: 2			
Direction: north	Eggers & Reed: Fresh (Wet) Meadow			
Remarks:

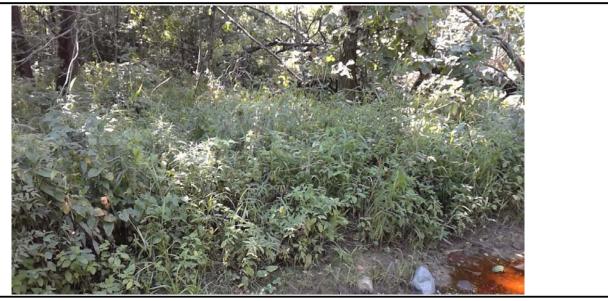
Site Photograph 2 Sampling Point: w-139n25w8-ar1

Latitude: 46.8681744207133	Cowardin Classification: PEM	
Longitude: -93.8726331387589	Circular 39: 2	
Direction: south	Eggers & Reed: Fresh (Wet) Meadow	
Remarks:
