WETLAND DETERMINATION DATA FORM - North Central and Northeast Region

Project/Site: SPP		City/County: Cass		Sampling Date: 2016-08-04		
Applicant/Owner: Enbridge			State: Minnesota	Samplir	ng Point: w-139n25w8-as1	
Investigator(s): DPT, MGH		Section, Townshi	p, Range: <u>S8, T139</u> N, R25	W		
Landform (hillslope, terrace, etc.):	Depression		Local Relief (concave, co	nvex, none): CC	Slope (%): 0-2%	
Subregion (LRR or MLRA):		 Latitude: 46	5.8679963052 Long	gitude: -93.86992268	Datum: NAD83	
Soil Map Unit Name: 142		_		NWI Cla	ssification: N/A	
Are climatic/hydrologic conditions	on the site typic	cal for this time of year	? (if no, explain in Remark		Yes	
Are Vegetation No , Soil No ,		•	•	,

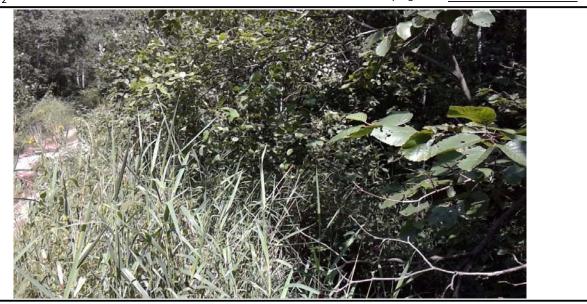
Site Photograph 2 Sampling Point: w-139n25w8-as1

Latitude: 46.868008417121	Cowardin Classification: PSS			
Longitude: -93.8699539472292	Circular 39: 6			
irection: west	Eggers & Reed: Shrub-Carr/Alder Thicket			
marks:
