WETLAND DETERMINATION DATA FORM - North Central and Northeast Region

Project/Site: SPP	City/County: Cass		Sampling Date: 2016-08-04	
Applicant/Owner: Enbridge		State: Minnesota	Samplin	g Point: <u>w-139n25w8-at1</u>
Investigator(s): DPT, MGH	Section, Townsh	ip, Range: <u>S8, T139N, R25</u> W	V	
Landform (hillslope, terrace, etc.): Depression		Local Relief (concave, con-	vex, none): CC	Slope (%): 0-2%
Subregion (LRR or MLRA):	Latitude: 4	6.8682994367 Longi	tude: -93.87066238	Datum: NAD83
Soil Map Unit Name: 142				ssification: N/A
Are climatic/hydrologic conditions on the site	typical for this time of year	r? (if no, explain in Remarks		Yes
Are Vegetation No_, Soil No, or Hydrolog		,	•	
Are Vegetation No_, Soil No_, or Hydrology	No naturally problemati	c? (If needed, explain any	answers in Remarks)	
SUMMARY OF FINDINGS - Attach site map	showing sampling point lo	ocations, transects, importa	ant features, etc.	
Hydrophytic Vegetation Present?	Yes	Is the Sampled Area

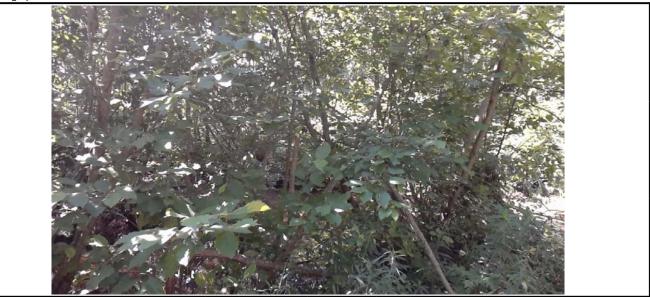
Site Photograph 1 Sampling Point: w-139n25w8-at1

Latitude: 46.8682922702719	Cowardin Classification: PSS
Longitude: -93.8706837595383	Circular 39: 6
Direction: south	Eggers & Reed: Shrub-Carr/Alder Thicket
Remarks:

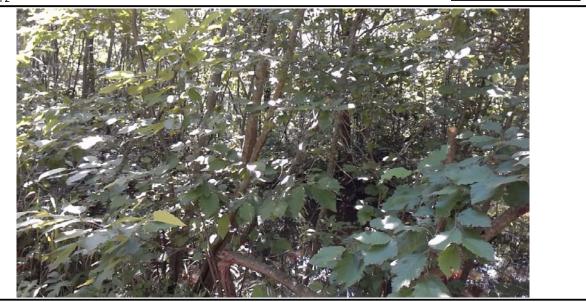
Site Photograph 2 Sampling Point: w-139n25w8-at1

878278632	Cowardin Classification: PSS			
5897106896	Circular 39: 6			
	Eggers & Reed: Shrub-Carr/Alder Thicket
