WETLAND DETERMINATION DATA FORM - North Central and Northeast Region

Project/Site: SPP	City/County: Cass		Sampling Date: 2016-08-04		
Applicant/Owner: Enbridge		State: Minnesota	Sampling Point: w-139n25w8-au1		
Investigator(s): DPT, MGH	Section, Townshi	p, Range: <u>S8, T139N, R25W</u>			
Landform (hillslope, terrace, etc.): Depression		Local Relief (concave, conve	x, none): CC Slope (%): 0-2%		
Subregion (LRR or MLRA):	 Latitude: 40	5.8679285794 Longitu	de: -93.87003064 Datum: NAD83	_	
Soil Map Unit Name: 142	_		NWI Classification: N/A		
Are climatic/hydrologic conditions on the site to	pical for this time of year	? (if no, explain in Remarks):	Yes		
, ,		, , ,			
Are Vegetation No_, Soil No_, or Hydrology No_ significantly disturbed? Are "Normal Circumstances" present? Yes_					
Are Vegetation No_, Soil No_, or Hydrology I	lo naturally problemati	c? (If needed, explain any ar	nswers in Remarks)		
SUMMARY OF FINDINGS - Attach site map s	Yes	<u> </u>	t features, etc.

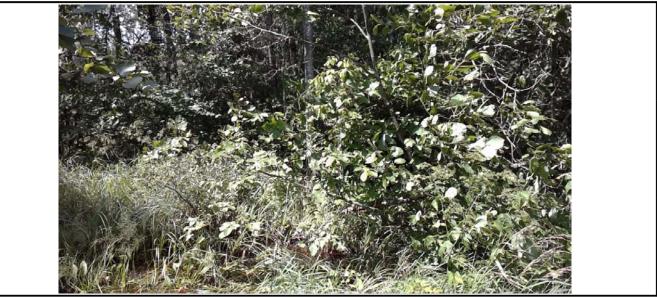
Site Photograph 1 Sampling Point: w-139n25w8-au1

Latitude: 46.8679315969784	Cowardin Classification: PSS
Longitude: -93.8700302225481	Circular 39: <u>6</u>
rection: west	Eggers & Reed: Shrub-Carr/Alder Thicket

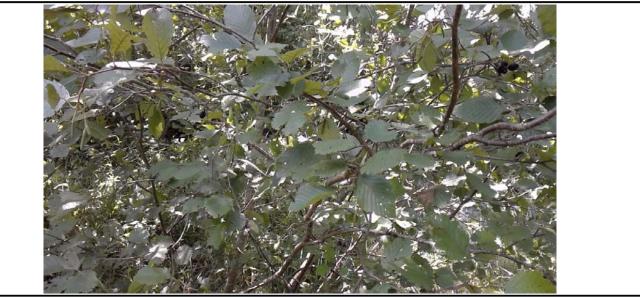
Site Photograph 2 Sampling Point: w-139n25w8-au1

Latitude: 46.8679315131594	Cowardin Classification: PSS	
Longitude: -93.8700316474716	Circular 39: 6	
Direction: south	Eggers & Reed: Shrub-Carr/Alder Thicket	
Remarks:
