WETL	AND DETER	MINATION DATA F	ORM - North Cer	ntral and Nor	theast Region			
Project/Site: SPP	City	City/County: Cass			Sampling Date: 2016-08-04			
Applicant/Owner: Enbridge		State: Minnesota			Sampling Point: w-139n25w8-aw1			
Investigator(s): DPT, MGH		Section, Townshi	p, Range: S8, T139	N, R25W				
Landform (hillslope, terrace, etc.): Depr	ession		Local Relief (concave, convex, none): CC Slope (%): 0-2%					
Subregion (LRR or MLRA):								
Soil Map Unit Name: 797				-	NWI Clas	sification: PSSBg		
Are climatic/hydrologic conditions on th	ne site typical	l for this time of year	? (if no, explain in R	emarks):		Yes		
Are Vegetation <u>No</u> , Soil <u>No</u> , or Hy	/drology NO	_ significantly disturb	oed? Are "Normal (Circumstances'	' present? Yes			
Are Vegetation <u>No</u> , Soil <u>No</u> , or Hyd	rology No	naturally problemation	c? (If needed, expl	ain any answei	rs in Remarks)			
SUMMARY OF FINDINGS - Attach sit	e map showi	ing sampling point lo	cations, transects,	important fea	tures, etc.

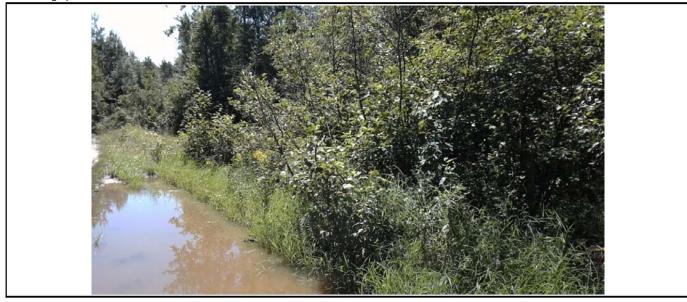
Site Photograph 1

Cowardin Classification: PSS

Circular 39: 6

Direction: south

Eggers & Reed: Shrub-Carr/Alder Thicket

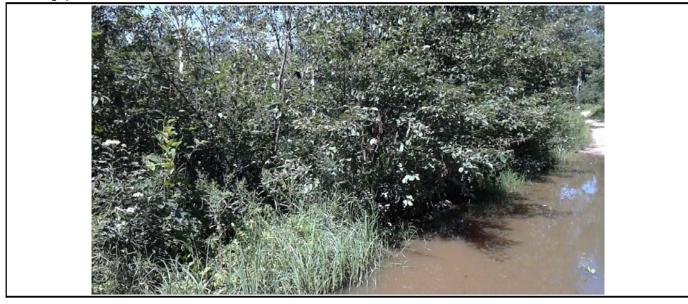
Site Photograph 2

Cowardin Classification: <u>PSS</u> Circular 39: <u>6</u>

Direction: north

Eggers & Reed: Shrub-Carr/Alder Thicket
