WETLAND DETERMINATION DATA FORM - North Central and Northeast Region

Project/Site: SPP	City/County: Cass		Sampling Date: 2016-07-27			
Applicant/Owner: Enbridge	State: Minnesota Sampling Point: w-139n26w20-ab1			g Point: w-139n26w20-ab1		
Investigator(s): DPT, MGH						
Landform (hillslope, terrace, etc.): Depression		Local Relief (concave, con		Slope (%): 0-2%		
Subregion (LRR or MLRA):	Latitude: 46	•	itude: -94.00535001	Datum: NAD83		
Soil Map Unit Name: 549	_			ssification: N/A		
Are climatic/hydrologic conditions on the site typical for this time of year? (if no, explain in Remarks): Yes						
Are Vegetation No_, Soil No_, or Hydrology No_ significantly disturbed? Are "Normal Circumstances" present? Yes_						
Are Vegetation No_, Soil No_, or Hydrology N	o naturally problemati	c? (If needed, explain any	answers in Remarks)			
			_			
SUMMARY OF FINDINGS - Attach site map s		1	ant features, etc.			
Hydrophytic Vegetation Present?	Yes	Is the Sampled Area				
Hydric Soil Present?	Yes	within a Wetland?		Yes

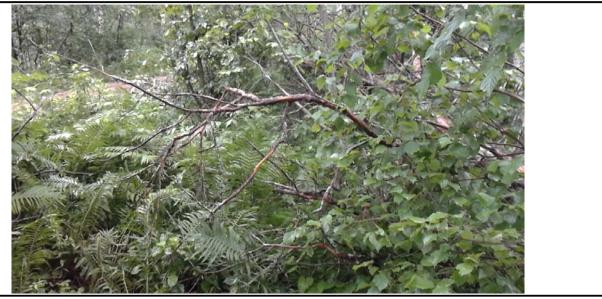
Site Photograph 2 Sampling Point: w-139n26w20-ab1

Latitude: 46.8405639706616	Cowardin Classification: PSS	
Longitude: -94.0053499304634	Circular 39: 6	
Direction: west	Eggers & Reed: Shrub-Carr/Alder Thicket	
Remarks:
