WETLAND DETERMINATION DATA FORM - North Central and Northeast Region

Site Photograph 1 Sampling Point: w-139n28w31-aa1

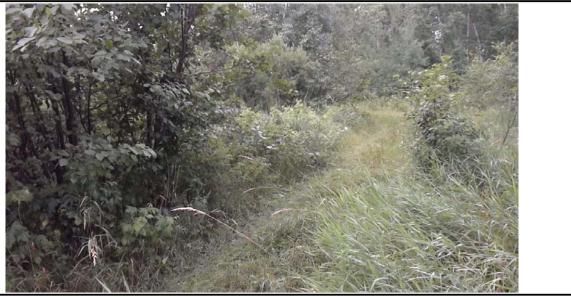
Latitude: 46.8074009707633	Cowardin Classification: PSS
Longitude: -94.2700281367584	Circular 39: 6
Direction: west	Eggers & Reed: Shrub-Carr/Alder Thicket
Remarks:	
west

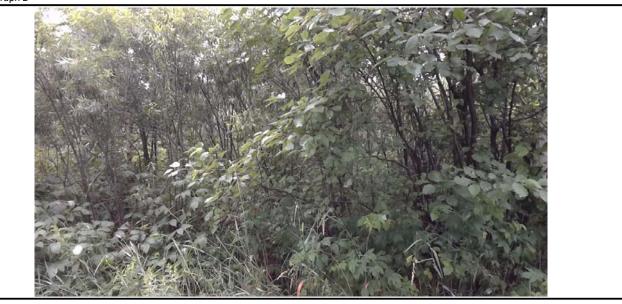
Site Photograph 2 Sampling Point: w-139n28w31-aa1

Latitude:	46.8074011384014	Cowardin Classification: PSS		
Longitude:	-94.2700281367584	Circular 39: 6		
Direction: sout	th	Eggers & Reed: Shrub-Carr/Alder Thicket		
Remarks:
