WETLAND DETERMINATION DATA FORM - North Central and Northeast Region

Project/Site: SPP	City/County: Aitkin		Sampling Date: 2016-08-24			
Applicant/Owner: Enbridge		State: Minnesota	Sampling Point: Al036ah1W			
Investigator(s): ZCW, MGH						
Landform (hillslope, terrace, etc.): Depression		Local Relief (concave, conv		Slope (%): 0-2%		
Subregion (LRR or MLRA):	 Latitude: 4	•	tude: -93.67597516	Datum: NAD83		
Soil Map Unit Name: 204B		2011811				
Are climatic/hydrologic conditions on the site typical for this time of year? (if no, explain in Remarks):						
Are Vegetation No_, Soil No_, or Hydrology No_ significantly disturbed? Are "Normal Circumstances" present? Yes_						
Are Vegetation No_, Soil No_, or Hydrology	No naturally problemati	c? (If needed, explain any a	answers in Remarks)			
SUMMARY OF FINDINGS - Attach site map	showing sampling point lo	ocations, transects, importa	ant features, etc.			
Hydrophytic Vegetation Present?	Yes					
Hydric Soil Present?	Yes	within a Wetland?		Yes

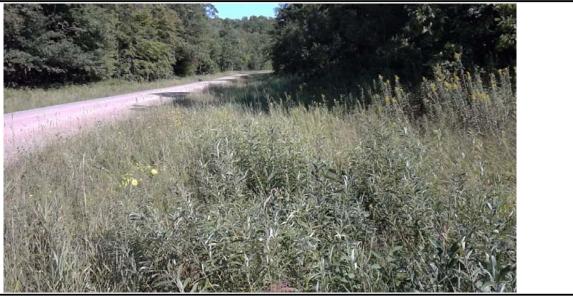
Site Photograph 1 Sampling Point: AI036ah1W

Latitude: 46.8159462791372	Cowardin Classification: PEM			
Longitude: -93.6759730708726	Circular 39: 2			
Direction: North	Eggers & Reed: Fresh (Wet) Meadow			
Remarks

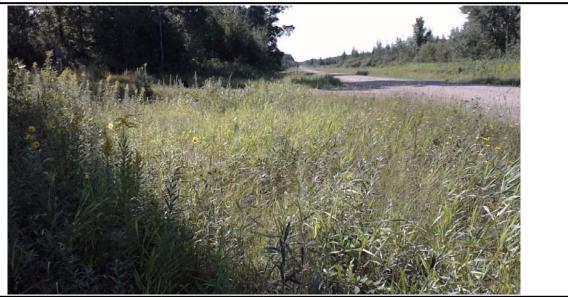
Site Photograph 2 Sampling Point: Al036ah1W

Latitude: 46.8159459019516	Cowardin Classification: PEM			
Longitude: -93.6759733223297	Circular 39: 2			
Direction: South	Eggers & Reed: Fresh (Wet) Meadow			
Remarks:
