WETLA	ND DETEF	RMINATION DATA F	ORM - North Cei	ntral an	d Northeast Region	ı		
Project/Site: SPP		City/County: <u>Aitkin</u>			Sampling Date: 2016-08-25			
Applicant/Owner: Enbridge		State: Minnesota			Sampling Point: AI059a4U			
Investigator(s): ZCW, MGH		Section, Township	o, Range: S35, T50		/	· <u> </u>		
Landform (hillslope, terrace, etc.): Should	er	Local Relief (concave, convex, none): VL Slope (%): 3-7%						
Subregion (LRR or MLRA):		Latitude: 46	Datum: NA	D83				
Soil Map Unit Name: 628				Ū	NWI Cla	- assification: N/A		
Are climatic/hydrologic conditions on the	site typica	al for this time of year	? (if no, explain in F	Remarks)		No		
Are Vegetation <u>No</u> , Soil <u>No</u> , or Hyd						-		
Are Vegetation <u>No</u> , Soil <u>No</u> , or Hydro	logy <u>No</u>	naturally problematic	? (If needed, expl	lain any a	answers in Remarks)			
SUMMARY OF FINDINGS - Attach site	map show	ing sampling point lo	cations, transects,	, importa	ant features, etc.

Sampling Point: AI059a4U

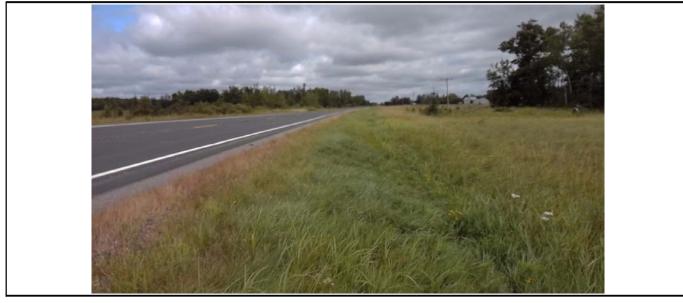
Site Photograph 1

Latitude: 46.7708523525361

Longitude: -93.6128623691328

Direction: North

Remarks: Upland Cowardin Classification:

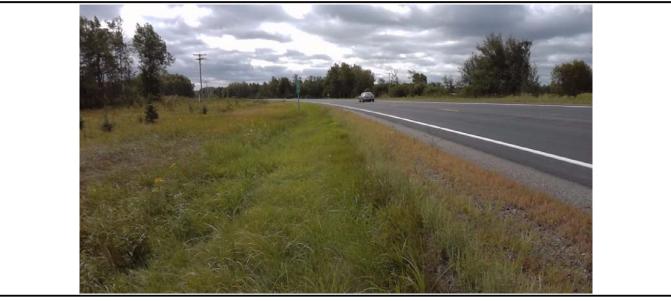
Site Photograph 2

Latitude: 46.7708646320242

Longitude: -93.6129008420684

Direction: South

Remarks: Upland Cowardin Classification:
