## WETLAND DETERMINATION DATA FORM - North Central and Northeast Region

Project/Site: SPP	City/County: Aitkin		Sampling Date: 2016-08-25		
Applicant/Owner: Enbridge		State: Minnesota	Sampling Point: Al059a5W		
Investigator(s): ZCW, MGH	Section, Townshi	p, Range: S35, T50N, R26W	. 9		
Landform (hillslope, terrace, etc.): Depression		Local Relief (concave, convex	, none): CL Slope (%): 0-2%		
Subregion (LRR or MLRA):		, ,	e: -93.61281693 Datum: NAD83		
Soil Map Unit Name: 628		2011811414	NWI Classification: N/A		
Are climatic/hydrologic conditions on the sit	te typical for this time of year	2 (if no explain in Remarks):	No		
· -					
Are Vegetation No_, Soil No_, or Hydrology No_ significantly disturbed? Are "Normal Circumstances" present? Yes_					
Are Vegetation No_, Soil No_, or Hydrology No_ naturally problematic? (If needed, explain any answers in Remarks)					
SUMMARY OF FINDINGS - Attach site ma	ap showing sampling point lo	ocations, transects, important	features, etc.

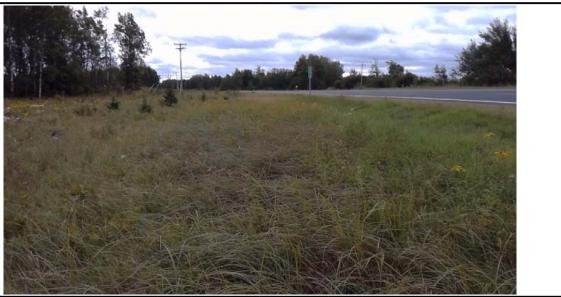
Site Photograph 1 Sampling Point: Al059a5W

Latitude: 46.7708578007731  Longitude: -93.6128272489585	Cowardin Classification: PEM  Circular 39: 2
<u> </u>	
Direction: South	Eggers & Reed: Fresh (Wet) Meadow
Remarks:
