WETLAND DETERMINATION DATA FORM - North Central and Northeast Region

Project/Site: SPP	City/County: Aitki	in	Sampling Date: 2016-08-29		
Applicant/Owner: Enbridge		State: Minnesota	Sampling Point: u-47n22w14-aa1		
Investigator(s): DPT, MGH	Section, To	wnship, Range: S14, T47N, F	 R22W		
Landform (hillslope, terrace, etc.): Rise		Local Relief (concave,			
Subregion (LRR or MLRA):	Latitu	•	ongitude: -93.09190873 Datum: NAD83		
Soil Map Unit Name: 990			NWI Classification: N/A

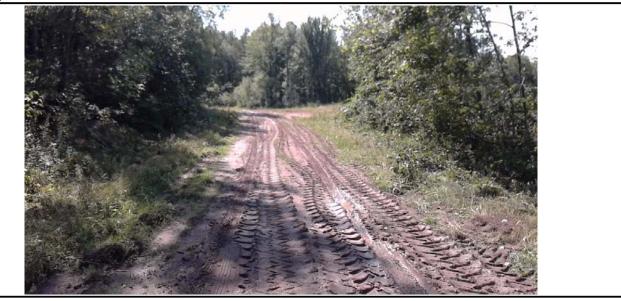
Site Photograph 1 Sampling Point: u-47n22w14-aa1

Latitude:	46.5596755408184	Cowardin Classification:		
Longitude:	-93.0919988361123	Circular 39:		
Direction: Sou	th	Eggers & Reed:		
Remarks:				
Upland				
I

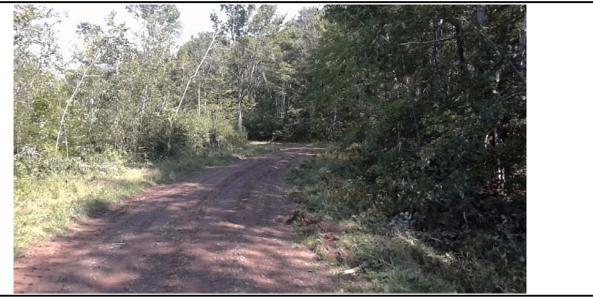
Site Photograph 2 Sampling Point: u-47n22w14-aa1

Latitude:	46.5598229365857	Cowardin Classification:
Longitude	: -93.0918276776495	Circular 39:
Direction: No	rth	Eggers & Reed:
Remarks:		
Upland
