WETLAND DETERMINATION DATA FORM - North Central and Northeast Region

Site Photograph 1 Sampling Point: u-50n26w17-aa1

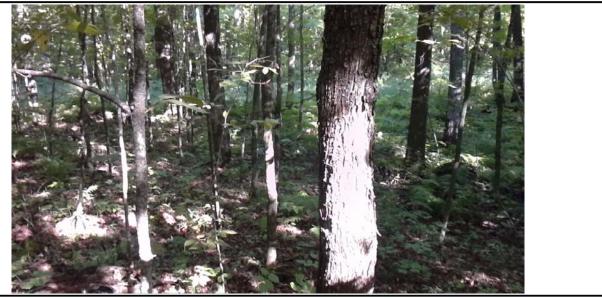
Latitude:	46.8198474264208	Cowardin Classification:
Longitude:	: -93.6769670807698	Circular 39:
Direction: Nor	rth	Eggers & Reed:
Remarks:		
Upland

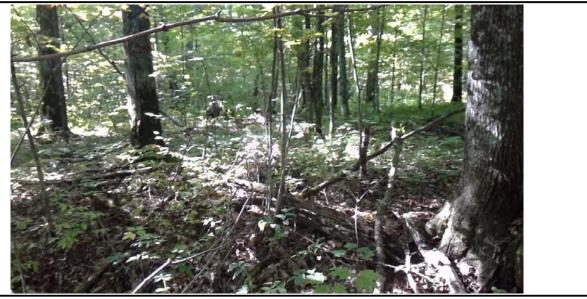
Site Photograph 2 Sampling Point: u-50n26w17-aa1

Latitude: 46.819835985123	Cowardin Classification:			
Longitude: -93.6768866983183	Circular 39:			
Direction: South	Eggers & Reed:			
Remarks:				
Upland
