WETLAND DETERMINATION DATA FORM - North Central and Northeast Region

Project/Site: SPP	City/County: Aith	City/County: Aitkin		Sampling Date: 2016-08-23	
Applicant/Owner: Enbridge		State: Minnesota	Samplir	ng Point: <u>u-50n26w17-ae1</u>	
Investigator(s): ZCW, MGH	Section, To	ownship, Range: S18, T50N,	R26W		
Landform (hillslope, terrace, etc.): Rise		Local Relief (concave	e, convex, none): VV	Slope (%): 0-2%	
Subregion (LRR or MLRA):	Latit	ude: 46.8194367969	Longitude: -93.67703245	Datum: NAD83	
Soil Map Unit Name: 928C			NWI Cla	ssification: N/A	
Are climatic/hydrologic conditions on	the site typical for this time	of year? (if no, explain in Re		No	
. , .		, , , , ,	•		
Are Vegetation No_, Soil No, or F	lydrology <u>NO</u> significantly	disturbed? Are "Normal Cir	cumstances" present? Yes		
Are Vegetation No , Soil No , or Hy	drology No naturally prob	lematic? (If needed, explai	n any answers in Remarks)		
SUMMARY OF FINDINGS - Attach s	te map showing sampling p	point locations, transects, in	nportant features, etc.

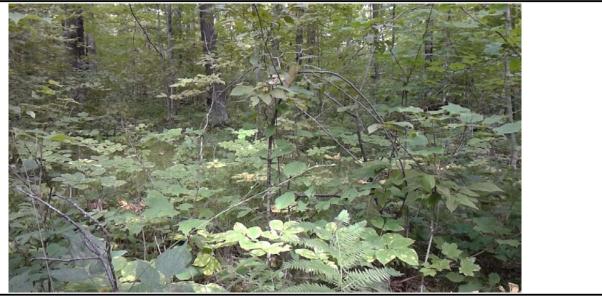
Site Photograph 1 Sampling Point: u-50n26w17-ae1

113	
Latitude:	46.8194930395547	Cowardin Classification:
Longitude:	-93.6769690924265	Circular 39:
Direction: East	t	Eggers & Reed:
Remarks:		
Upland		
1

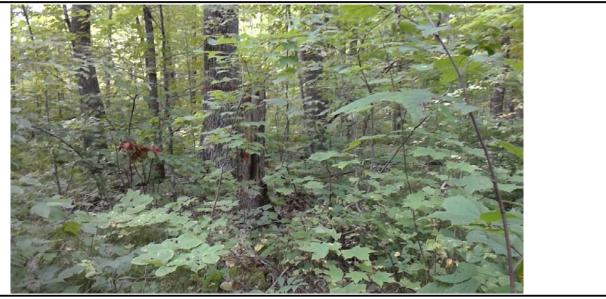
Site Photograph 2 Sampling Point: u-50n26w17-ae1

Latitude: 46.8195017986436	Cowardin Classification:
Longitude: -93.6769645661988	Circular 39:
Direction: North	Eggers & Reed:
Remarks:	
Upland
