## WETLAND DETERMINATION DATA FORM - North Central and Northeast Region

Project/Site: SPP	City/County: Aitkin		Sampling Date: 2016-08-24		
Applicant/Owner: Enbridge		State: Minnesota	Samplin	g Point: <u>u-50n26w17-af1</u>	
Investigator(s): ZCW, MGJ Section, Township, Range: S17, T50N, R26W					
Landform (hillslope, terrace, etc.): Rise		Local Relief (concave, cor	nvex, none): VV	Slope (%): <u>3</u> -7%	
Subregion (LRR or MLRA):	 Latitude: <sup>4</sup>	6.8160418747 Long	itude: -93.67654681	Datum: NAD83	
Soil Map Unit Name: 204B	<del></del>		NWI Clas	ssification: N/A

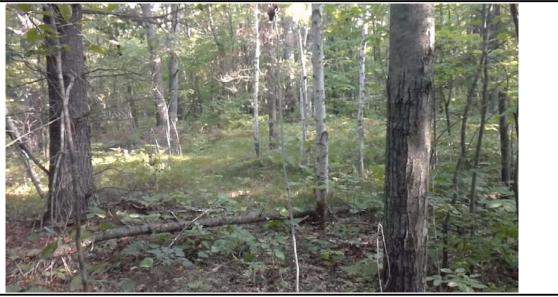
Site Photograph 2 Sampling Point: u-50n26w17-af1

Latitude:	46.8160393601719	Cowardin Classification:		
Longitude:	-93.6766368337848	Circular 39:		
Direction: Nor	th	Eggers & Reed:		
Remarks:				
Upland
