WETLAN	ND DETERMINATION	DATA FORM - North Central	and Northeast Region				
Project/Site: SPP	City/County: Ait	kin	Sampling Date: 2016-08-24				
Applicant/Owner: Enbridge		State: Minnesota Sampling Point: u-50n26w17-ah1					
Investigator(s): ZCW, MGH	Section, 1	Section, Township, Range: S17, T50N, R26W					
Landform (hillslope, terrace, etc.): Should	er	Local Relief (concave, co	onvex, none): <u>VL</u> Slope (%): <u>3-7%</u>				
Subregion (LRR or MLRA):	Latit	ude: 46.8157014856 Lor	ngitude: <u>-93.67607130</u> Datum: <u>NAD83</u>				
Soil Map Unit Name: 204B			NWI Classification: N/A				
Are climatic/hydrologic conditions on the	site typical for this time	of year? (if no, explain in Remai	rks): <u>No</u>				
Are Vegetation <u>No</u> , Soil <u>No</u> , or Hyd	rology <u>No</u> significantly	v disturbed? Are "Normal Circur	nstances" present? Yes				
Are Vegetation <u>No</u> , Soil <u>No</u> , or Hydro	logy <u>No</u> naturally pro	plematic? (If needed, explain an	ny answers in Remarks)

SUMMARY OF FINDINGS - Attach site	map showing sampling	point locations, transects, impo	rtant features, etc.				
Hydrophytic Vegetation Present?	No	Is the Sampled Area					
Hydric Soil Present?	No	within

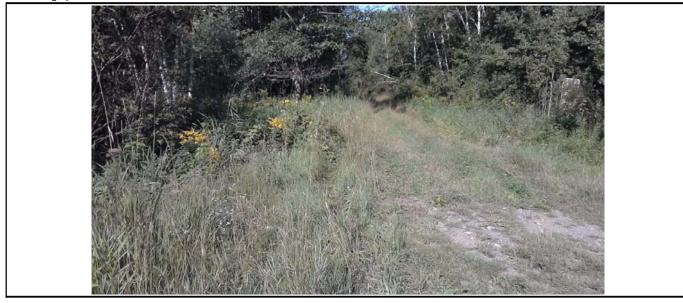
Site Photograph 1

Latitude: 46.8158012303028

Longitude: -93.6761063431331

Direction: West

Remarks: Upland Cowardin Classification:

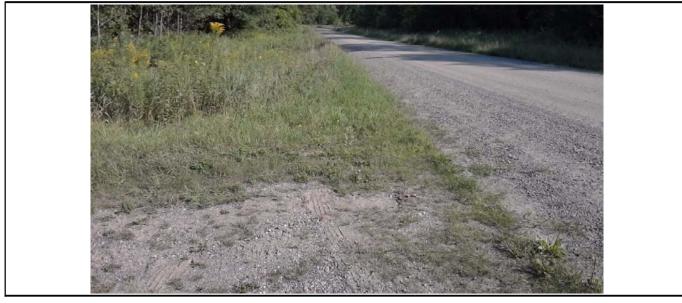
Site Photograph 2

Latitude: 46.8158019008551

Longitude: -93.6761072651424

Direction: North

Remarks: Upland Cowardin Classification:
