WETLAND DETERMINATION DATA FORM - North Central and Northeast Region

Project/Site: SPP	City/County: Aitkin		Sampling Date: 2016-08-23	
Applicant/Owner: Enbridge		State: Minnesota	Sampling Point: u-50n26w18-ab1	
Investigator(s): ZCW, MGH	Section, Townshi	p, Range: S18, T50N, R26W		
Landform (hillslope, terrace, etc.): Rise		Local Relief (concave, convex	s, none): VL Slope (%): 3-7%	
Subregion (LRR or MLRA):	Latitude: 46	,	le: -93.67968742 Datum: NAD83	
Soil Map Unit Name: 204B			NWI Classification: N/A	
Are climatic/hydrologic conditions on the	site typical for this time of year	? (if no explain in Remarks):	No	
Are Vegetation No , Soil No , or Hyd	rology No significantly disturb	bed? Are "Normal Circumstan	ces" present? Yes	
Are Vegetation No , Soil No , or Hydro	ology No naturally problemati	c? (If needed, explain any ans	swers in Remarks)	
<u> </u>				
SUMMARY OF FINDINGS - Attach site		cations, transects, important	features, etc.	
Hydrophytic Vegetation Present?	<u>No</u>	Is the Sampled Area

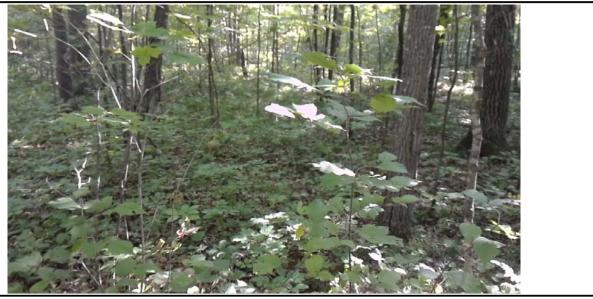
Site Photograph 1 Sampling Point: u-50n26w18-ab1

A A A A A A A A A A A A A A A A A A A	
Latitude: 46.8163105566491	Cowardin Classification:
Longitude: -93.6796862539776	Circular 39:
Direction: North	Eggers & Reed:
Remarks:	
Upland

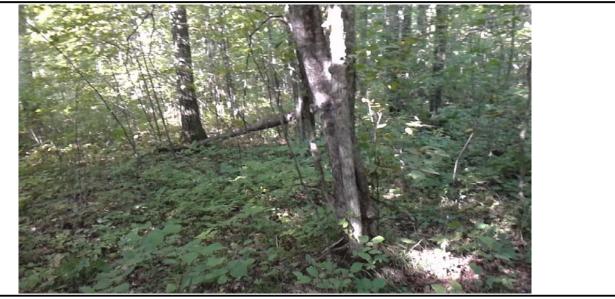
Site Photograph 2 Sampling Point: <u>u-50n26w18-ab1</u>

Latitude: 46.8163053598691	Cowardin Classification:			
Longitude: -93.6797066220023	Circular 39: Eggers & Reed:			
ction: South				
narks:				
land
