WETLAND DETERMINATION DATA FORM - North Central and Northeast Region

Project/Site: SPP	City/County: Aitkin		Sampling Date: 2016-08-23			
Applicant/Owner: Enbridge		State: Minnesota	Sampling Point: u-50n26w18-ac1			
Investigator(s): ZCW, MGH						
Landform (hillslope, terrace, etc.): Side Slope		Local Relief (concave, co	nvex, none): VL Slope (%): 8-15%			
Subregion (LRR or MLRA):	Latitude: 46	5.8181000929 Long	itude: -93.67839577 Datum: NAD83			
Soil Map Unit Name: 204B			NWI Classification: N/A			
Are climatic/hydrologic conditions on the site ty	pical for this time of year	? (if no. explain in Remark				
· · · · · · · · · · · · · · · · · · ·	•		· ———			
Are Vegetation No , Soil No , or Hydrology	significantly disturb	bed? Are "Normal Circum	stances" present? <u>Yes</u>			
Are Vegetation No , Soil No , or Hydrology N	o naturally problemati	c? (If needed, explain any	answers in Remarks)			
CLIMANA DV OF FINIDINGS. Attack site good o			to the state of th			
SUMMARY OF FINDINGS - Attach site map s	No	<u> </u>	cant reatures, etc.

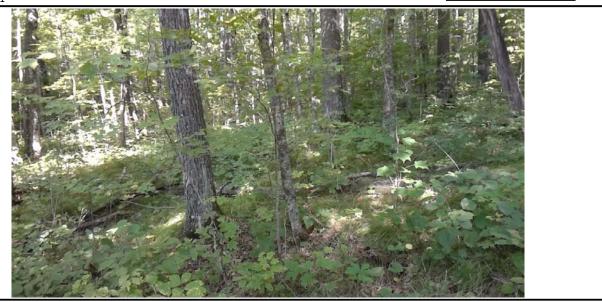
Site Photograph 1 Sampling Point: u-50n26w18-ac1

A CAMPAGE TO THE		
Latitude:	46.8181747757334	Cowardin Classification:	
Longitude:	-93.6784668547042	Circular 39:	
Direction: Wes	st	- Eggers & Reed:	
Remarks:			
Upland			
I

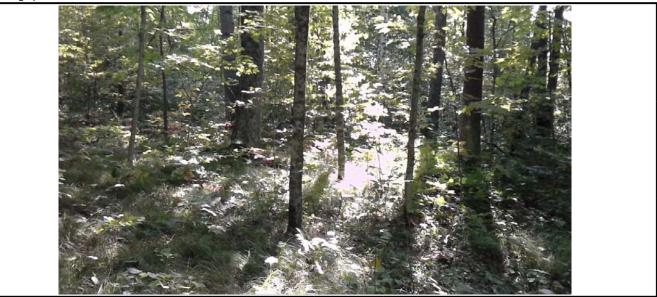
Site Photograph 2 Sampling Point: u-50n26w18-ac1

Latitude: 46.818188228688	Cowardin Classification:
Longitude: -93.6784764100739	Circular 39:
Direction: East	Eggers & Reed:
Remarks:	
Upland	
I .
