WETLAND DETERMINATION DATA FORM - North Central and Northeast Region

Project/Site: SPP	City/County: Aitkin		Sampling Date: 2016-08-23			
Applicant/Owner: Enbridge		State: Minnesota	Sampling Point: u-50n26w18-ad1			
Investigator(s): ZCW, MGH	Section, Townsh	ip, Range: S18, T50N, R26W	· · · · · · · · · · · · · · · · · · ·			
Landform (hillslope, terrace, etc.): Rise		Local Relief (concave, convex,	none): VL Slope (%): 0-2%			
Subregion (LRR or MLRA):	Latitude: 4	•	e: -93.67926380 Datum: NAD83			
Soil Map Unit Name: 928D			NWI Classification: N/A			
Are climatic/hydrologic conditions on the	e site typical for this time of year	? (if no explain in Remarks):	No			
_						
Are Vegetation No , Soil No , or Hy	drology No significantly distur	bed? Are "Normal Circumstance	es" present? Yes			
Are Vegetation No , Soil No , or Hydrology No naturally problematic? (If needed, explain any answers in Remarks)						
			·			
SUMMARY OF FINDINGS - Attach site		ocations, transects, important fo	eatures, etc.

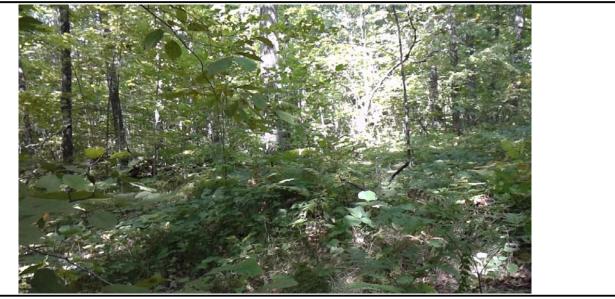
Site Photograph 1 Sampling Point: u-50n26w18-ad1

atitude: 46.8182928348396	Cowardin Classification:
ongitude: -93.6793176178762	Circular 39:
ction: West	Eggers & Reed:
narks:	
and

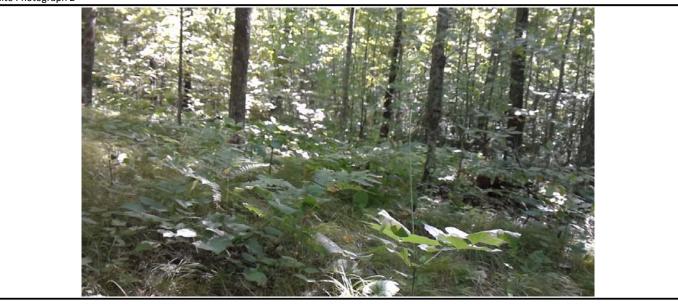
Site Photograph 2 Sampling Point: u-50n26w18-ad1

Latitude:	46.8182832375605	Cowardin Classification:		
Longitude:	-93.6793208868184	Circular 39:		
Direction: East	t	Eggers & Reed:		
Remarks:				
Upland
