## WETLAND DETERMINATION DATA FORM - North Central and Northeast Region

Project/Site: SPP	City/County: Aitkin		Sampling Date: 2016-08-23				
Applicant/Owner: Enbridge	State: Minnesota		Sampling Point: u-50n26w18-ae1				
Investigator(s): ZCW, MGH	Section, Townshi	p, Range: S18, T50N, R26					
Landform (hillslope, terrace, etc.): Side Slope		Local Relief (concave, co	nvex, none): VL Slope (%): 8-15%				
Subregion (LRR or MLRA):	Latitude: 46	5.8185279472 Long	gitude: -93.67773352 Datum: NAD83				
Soil Map Unit Name: 928D	_		NWI Classification: N/A				
Are climatic/hydrologic conditions on the site ty	pical for this time of year	? (if no, explain in Remark	s): No				
Are Vegetation No , Soil No , or Hydrology No significantly disturbed? Are "Normal Circumstances" present? Yes							
Are Vegetation No_, Soil No_, or Hydrology No_ naturally problematic? (If needed, explain any answers in Remarks)							
SUMMARY OF FINDINGS - Attach site map s	howing sampling point lo	ocations, transects, impor	tant features, etc.

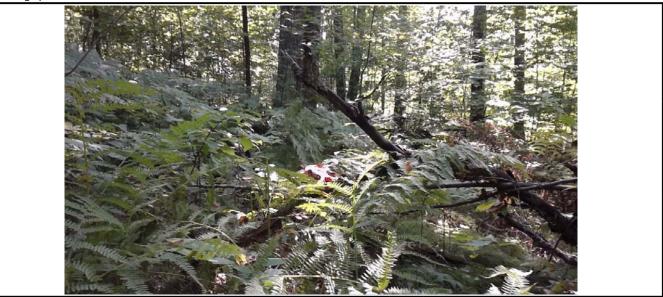
Site Photograph 1 Sampling Point: u-50n26w18-ae1

Prince of the North	
Latitude: 46.8185279891331	Cowardin Classification:
Longitude: -93.677734276367	Circular 39:
Direction: East	Eggers & Reed:
Remarks:	
Upland	
I .

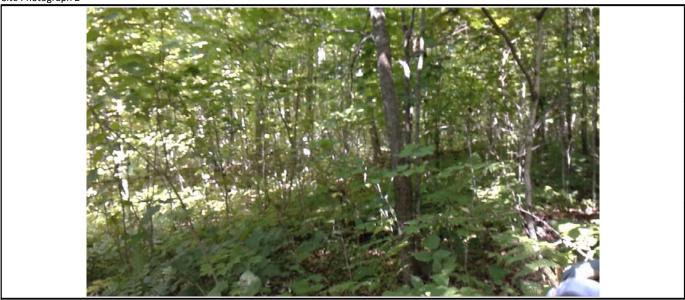
Site Photograph 2 Sampling Point: u-50n26w18-ae1

Latitude:	46.8185279472236	Cowardin	n Classification:
Longitude:	-93.6777346116432	Circular 39: _	
Direction: Wes	st	- Eggers & Reed	l:
Remarks:			
Upland
