WETLAND DETERMINATION DATA FORM - North Central and Northeast Region

Project/Site: SPP	City/County: Aitkin		Sampling Date: 2016-08-19			
Applicant/Owner: Enbridge		State: Minnesota	Sampling Point: u-50n26w18-d1			
Investigator(s): ZCW, MGH	Section, Townsh	nip, Range: <u>\$18, T50N, R26\</u>	N			
Landform (hillslope, terrace, etc.): Side Slop	pe	Local Relief (concave, cor	nvex, none): <u>VL</u> Slope (%): <u>8-15%</u>			
Subregion (LRR or MLRA):	Latitude: 4	16.8224421283 Long	itude: -93.68489401 Datum: NAD83			
Soil Map Unit Name: 204B			NWI Classification: N/A			
Are climatic/hydrologic conditions on the s	site typical for this time of yea	ar? (if no, explain in Remark	s): <u>No</u>			
Are Vegetation No_, Soil No_, or Hydrology No_ significantly disturbed? Are "Normal Circumstances" present? Yes_						
Are Vegetation No_, Soil No_, or Hydrology No_ naturally problematic? (If needed, explain any answers in Remarks)						
SUMMARY OF FINDINGS - Attach site m	nap showing sampling point	locations, transects, import	ant features, etc.

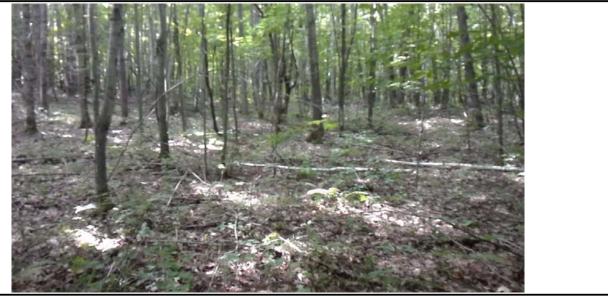
Site Photograph 1 Sampling Point: u-50n26w18-d1

Latitude: 46.8223845027823	Cowardin Classification:			
Longitude: -93.6848826148488	Circular 39:			
rection: South	Eggers & Reed:			
narks:

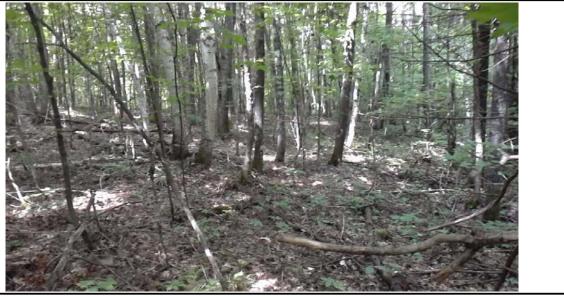
Site Photograph 2 Sampling Point: u-50n26w18-d1

Latitude:	46.8223845866014	Cowardin Classification:		
Longitude:	-93.6848825310298	Circular 39:		
Direction: West		Eggers & Reed:		
Remarks:
