WETLAND DETERMINATION DATA FORM - North Central and Northeast Region

Project/Site: SPP	City/County: Aitkin		Sampling Date: 2016-08-19		
Applicant/Owner: Enbridge		State: Minnesota	Sampling Point: u-50n26w18-h1		
Investigator(s): ZCW, MGH	Section, Townsh	ip, Range: S18, T50N, R26W	<u></u>		
Landform (hillslope, terrace, etc.): Side Slope		Local Relief (concave, conv	vex, none): VL Slope (%): 8-15%		
Subregion (LRR or MLRA):	Latitude: 46	5.8221311178 Longit	tude: -93.67880246 Datum: NAD83		
Soil Map Unit Name: 928C			NWI Classification: N/A		
Are climatic/hydrologic conditions on the site	typical for this time of year	? (if no explain in Remarks)			
			·		
Are Vegetation No , Soil No , or Hydrolo	gy No significantly disturb	bed? Are "Normal Circumst	tances" present? Yes		
Are Vegetation No_, Soil No_, or Hydrology	No naturally problemati	c? (If needed, explain any	answers in Remarks)		
SUMMARY OF FINDINGS - Attach site map		i -	ant features, etc.		
Hydrophytic Vegetation Present?	No	Is the Sampled Area

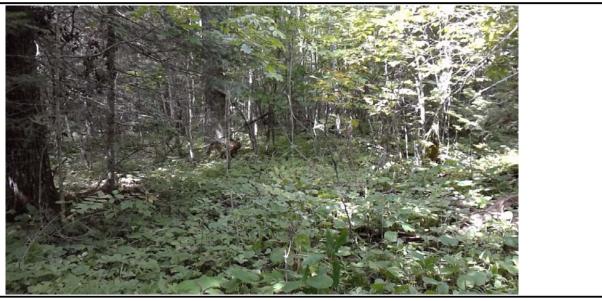
Site Photograph 1 Sampling Point: u-50n26w18-h1

Latitude: 46.8222447345469	Cowardin Classification:
Longitude: -93.6786303018161	Circular 39:
Direction: North	Eggers & Reed:
Remarks:

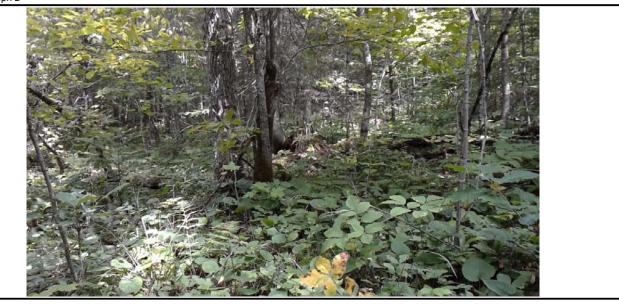
Site Photograph 2 Sampling Point: u-50n26w18-h1

Latitude:	46.8222452374611	Cowardin Classification:	
Longitude:	-93.6786303856351	Circular 39:	
Direction: East	<u>: </u>	Eggers & Reed:	
Remarks:
