WETLAND DETERMINATION DATA FORM - North Central and Northeast Region

Site Photograph 1 Sampling Point: u-50n26w18-k1

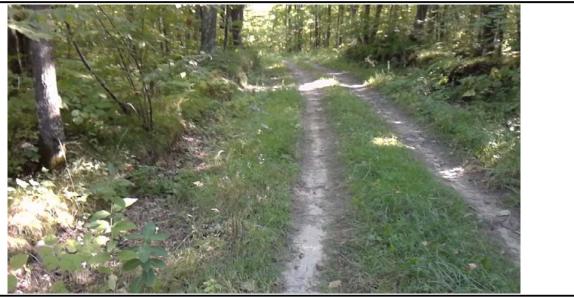
Site Photograph 2 Sampling Point: u-50n26w18-k1

文学 电型 风机	
Latitude:	46.8195923231978	Cowardin Classification:
Longitude:	-93.6775190290936	Circular 39:
Direction: Nor	theast	Eggers & Reed:
Remarks:		
Upland
