## WETLAND DETERMINATION DATA FORM - North Central and Northeast Region

Project/Site: SPP	City/County:	City/County: Aitkin		Sampling Date: 2016-08-22		
Applicant/Owner: Enbridge		State: Minnesota		Sampling Point: u-50n26w18-m1		
Investigator(s): ZCW, MGH	Section	n, Township, F	Range: <u>\$18,</u> T50N, I	R26W		
Landform (hillslope, terrace, etc.): Side SI	ope	Lo	ocal Relief (concave	, convex, none): VL	Slope	(%): 8-15%
Subregion (LRR or MLRA):	La	ititude: 46.81	19311487532 լ	 Longitude: -93.6796939	— 6	.D83
Soil Map Unit Name: 928D				NWI	Classification: N/A	
Are climatic/hydrologic conditions on the	site typical for this tir	ne of vear? (i	if no. explain in Ren		No	
Are Vegetation No_, Soil No_, or Hyd	rology <u>No</u> significa	ntly disturbed	l? Are "Normal Circ	cumstances" present? Y		
Are Vegetation No_, Soil No_, or Hydrology No_ naturally problematic? (If needed, explain any answers in Remarks)						
SUMMARY OF FINDINGS - Attach site				portant features, etc.		
Hydrophytic Vegetation Present?	No	I	the Sampled Area

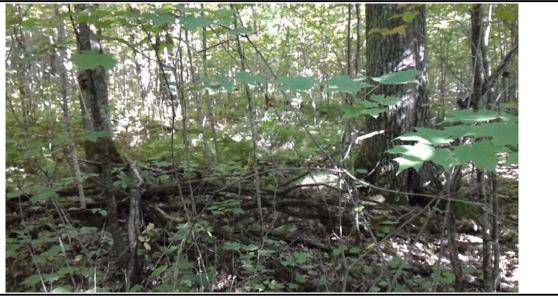
Site Photograph 1 Sampling Point: u-50n26w18-m1

Latitude:	46.8193525169481	Cowardin Classification:		
Longitude:	-93.6796468590327	Circular 39:		
Direction: Nor	th	Eggers & Reed:		
Remarks:				
Upland

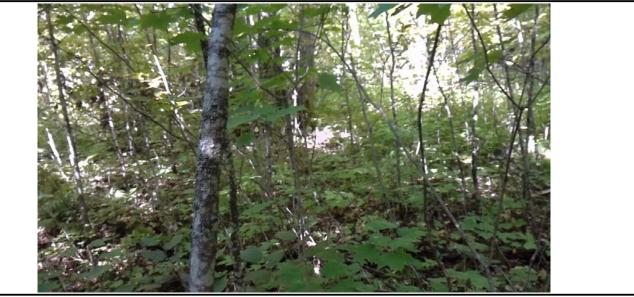
Site Photograph 2 Sampling Point: <u>u-50n26w18-m1</u>

Latitude: 46.8193640839744	Cowardin Classification:
Longitude: -93.6796056200691	Circular 39:
Direction: West	Eggers & Reed:
Remarks:	
Upland
