WETLAND DETERMINATION DATA FORM - North Central and Northeast Region

Site Photograph 1 Sampling Point: u-50n26w18-n1

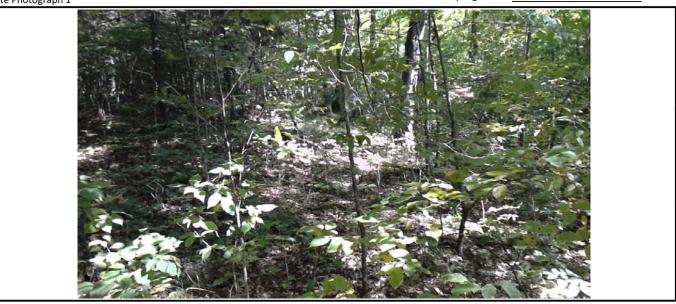
Latitude: 46.8187796138663	Cowardin Classification:	
Longitude: -93.6811654922493	Circular 39:	
Direction: North	Eggers & Reed:	
Remarks:		
Upland

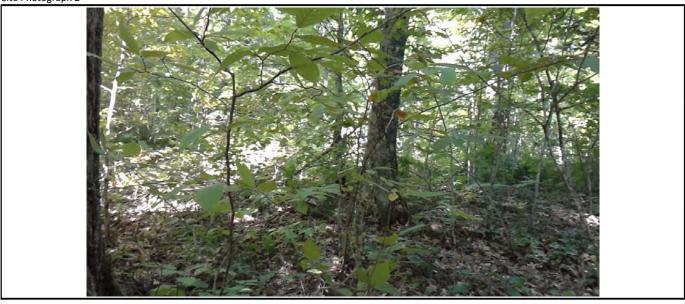
Site Photograph 2 Sampling Point: u-50n26w18-n1

Latitude: 46.8188167037878	Cowardin Classification:			
Longitude: -93.6811878719308	Circular 39:			
Direction: West	Eggers & Reed:			
Remarks:				
Upland
