WET	LAND DETERMI	NATION DATA	FORM - North Cer	ntral and	Northeast Region				
Project/Site: SPP	City/County: <u>Aitkin</u>			_	Sampling Date: 2016-08-22				
Applicant/Owner: Enbridge			State: Minnesota		Sampling	Point: <u>u-50</u>	n26w18-q1		
Investigator(s): ZCW, MGH		Section, Townshi	ip, Range: <u>S18, T50</u>	N, R26W					
Landform (hillslope, terrace, etc.): Side	e Slope		Local Relief (conca	ave, conve	ex, none): <u>VL</u>	Slope	e (%): <u>8-15%</u>		
Subregion (LRR or MLRA):		Latitude: 40	5.818719306073	Longitu	ıde: -93.68505964	Datum: N	IAD83		
Soil Map Unit Name: 928C		_			NWI Class	- ification: N/	Ά		
Are climatic/hydrologic conditions on	the site typical fo	r this time of year	? (if no, explain in R	Remarks):		No			
Are Vegetation <u>No</u> , Soil <u>No</u> , or	Hydrology <u>No</u> s	gnificantly distur	bed? Are "Normal (Circumsta	nces" present? Yes				
Are Vegetation <u>No</u> , Soil <u>No</u> , or Hy	drology <u>No</u> nat	urally problemati	c? (If needed, expl	lain any ar	nswers in Remarks)

Sampling Point: u-50n26w18-q1

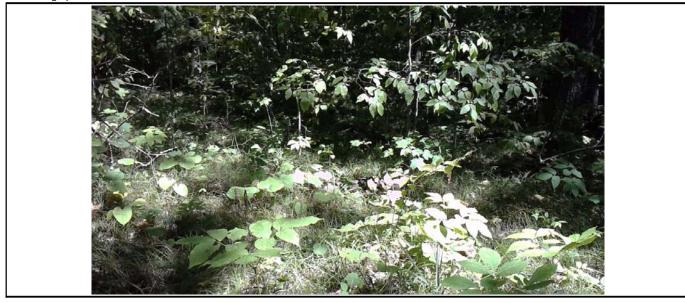
Site Photograph 1

Latitude: 46.818739129274

Longitude: -93.6850380153336

Direction: North

Remarks: Upland Site Photograph 2

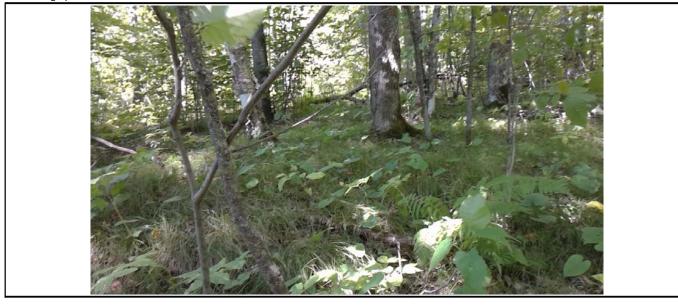
Latitude: 46.8187320884753

Longitude: -93.6850352493056

Direction: West

Remarks: Upland
