Applicant/Owner: Entridge State: Minnesota Sampling Point: U-S0n26w18-v1 Applicant/Owner: Entridge State: Sampling Point: U-S0n26w18-v1 Investigator(5); ZCW, MGH Section, Township, Range: Stampling Point: U-S0n26w18-v1 Investigator(5); ZCW, MGH Section, Township, Range: State: Montection: NAD83 Subregion (LRR or MLRA): Latitude: 46.8176416028 Longitude: 93.68318502 Datum: NAD83 Subregion (LRR or MLRA): Latitude: 46.8176416028 Longitude: 93.68318502 Datum: NAD83 Subregion (LRR or MLRA): Latitude: 46.8176416028 Longitude: 93.68318502 Datum: NAD83 Are climatic/hydrologic conditions on the site typical for this time of year? (If no, explain in Remarks): NO NO NO Are Climatic/hydrologic regeters No No<	Project/Site: SPP		ty/County: Aitkin		al and Northeast Region	ling Date: 2016-08-22
Investigator(s): ZCW, MGH						
Landform (hillslope, terrace, etc.): <u>Nise</u> Local Relief (concave, convex, none): <u>VV</u> Slope (K): <u>3-7%</u> Subregion (LRR or MLRA):						ling Point: u-50n26w18-v1

VEGETATION - Use scientific names of plants.

Northcentral and Northeast Region – Version 2.0

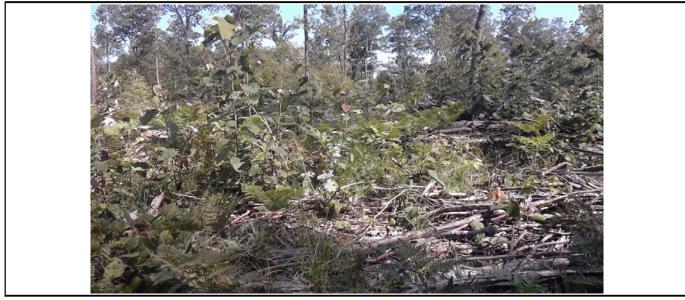
Site Photograph 1

Latitude: 46.817604010037

Longitude: -93.683096431283

Direction: East

Remarks: Upland Cowardin Classification:

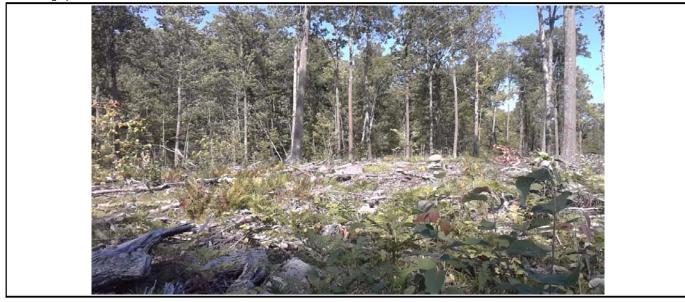
Site Photograph 2

Latitude: 46.8176036328513

Longitude: -93.6830862891801

Direction: North

Remarks: Upland Cowardin Classification:
