## WETLAND DETERMINATION DATA FORM - North Central and Northeast Region

Project/Site: SPP	City/County: Aitkin		Sampling Date: 2016-08-10			
Applicant/Owner: Enbridge		State: Minnesota	Sampling Point: u-50n26w5-aa1			
Investigator(s): ZCW, MGH	Section, Townsh	nip, Range: <u>S5, T50N, R26W</u>				
Landform (hillslope, terrace, etc.): Should	der	Local Relief (concave, conve	x, none): <u>VL</u> Slope (%): <u>3-7%</u>			
Subregion (LRR or MLRA):	Latitude: 4	6.8470587302 Longitu	de: -93.67716011 Datum: NAD83			
Soil Map Unit Name: 504B			NWI Classification: N/A			
Are climatic/hydrologic conditions on the	e site typical for this time of yea	r? (if no, explain in Remarks):	No			
Are Vegetation No , Soil No , or Hydrology No significantly disturbed? Are "Normal Circumstances" present? Yes						
Are Vegetation No , Soil No , or Hydrology No naturally problematic? (If needed, explain any answers in Remarks)						
SUMMARY OF FINDINGS - Attach site	map showing sampling point l	ocations, transects, importan	t features, etc.

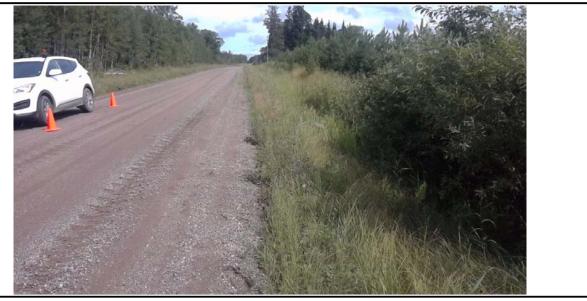
Site Photograph 1 Sampling Point: u-50n26w5-aa1

<b>发展文学</b> 李文 《 1707年		
Latitude:	46.8470472889457	Cowardin Classification:	
Longitude:	-93.6771641393133	Circular 39:	
Direction: Nor	th	Eggers & Reed:	
Remarks:			
Upland			
1

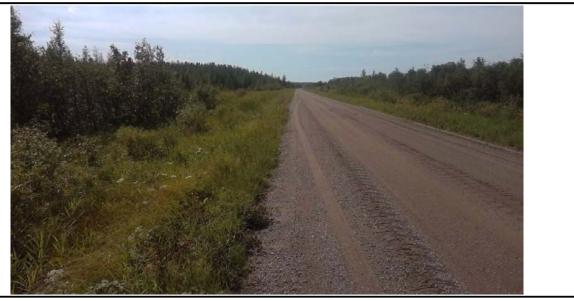
Site Photograph 2 Sampling Point: u-50n26w5-aa1

<b>文</b> 學 (2015年) 《 2015年) 《 2015年》 《 2015年
Latitude: 46.8470511027117	Cowardin Classification:
Longitude: -93.6771670729794	Circular 39:
Direction: South	Eggers & Reed:
Remarks:	
Upland
