## WETLAND DETERMINATION DATA FORM - North Central and Northeast Region

Project/Site: SPP	City/County: Aitkin		Sampling Date: 2016-08-09
Applicant/Owner: Enbridge		State: Minnesota	Sampling Point: u-50n26w6-a1
Investigator(s): ZCW, MGH	Section, Townsh	ip, Range: <u>S6, T50N, R26W</u>	
Landform (hillslope, terrace, etc.): Rise		Local Relief (concave, conve	ex, none): VL Slope (%): 0-2%
Subregion (LRR or MLRA):	Latitude: 4	5.8542785663 Longitu	ide: -93.67873608 Datum: NAD83
Soil Map Unit Name: 554			NWI Classification: N/A
Are climatic/hydrologic conditions on the s	ite typical for this time of year	? (if no. explain in Remarks):	
. , .	,	, , , ,	
Are Vegetation No , Soil No , or Hydro	ology <u>NO</u> significantly distur	bed? Are "Normal Circumsta	inces" present? res_
Are Vegetation No_, Soil No_, or Hydrold	ogy No naturally problemati	c? (If needed, explain any ar	nswers in Remarks)
SUMMARY OF FINDINGS - Attach site m	nan showing sampling point le	ocations transects importan	nt features, etc

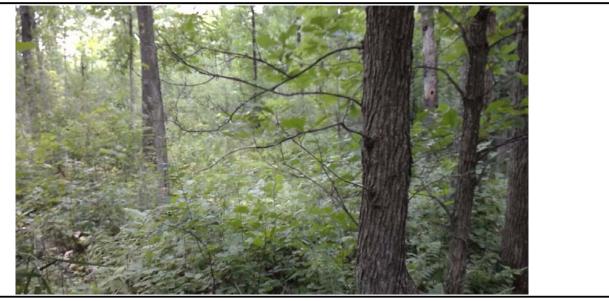
Site Photograph 1 Sampling Point: u-50n26w6-a1

Latitude: 46.8543120101531	Cowardin Classification:		
Longitude: -93.6786979437747	Circular 39:		
rection: North	Eggers & Reed:		
emarks:			
Ipland

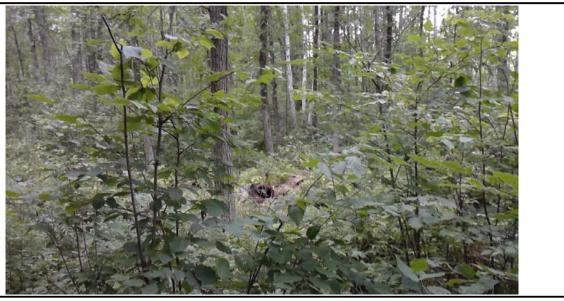
Site Photograph 2 Sampling Point: u-50n26w6-a1

Latitude:	46.8543187575851	Cowardin Classification:	
Longitude:	: -93.6787035596498	Circular 39:	
Direction: We	st	Eggers & Reed:	
Remarks:			
Upland
