WETLAND DETERMINATION DATA FORM - North Central and Northeast Region

Project/Site: SPP	City/County: Aitkin		Sampling Date: 2016-08-16
Applicant/Owner: Enbridge		State: Minnesota	Sampling Point: u-50n26w6-a12
Investigator(s): ZCW, MGH	Section, Townsh	ip, Range: S6, T50N, R26W	
Landform (hillslope, terrace, etc.): Rise		Local Relief (concave, cor	
Subregion (LRR or MLRA):	Latitude: 4	•	itude: -93.68131301 Datum: NAD83
Soil Map Unit Name: 204B			NWI Classification: N/ A
Are climatic/hydrologic conditions on the sit	e typical for this time of year	r? (if no explain in Remark	
Are Vegetation No , Soil No , or Hydrol	ogy <u>No</u> significantly distur	bed? Are "Normal Circum	stances" present? Yes
Are Vegetation No_, Soil No_, or Hydrolog	gy <u>No</u> naturally problemati	ic? (If needed, explain any	answers in Remarks)
SUMMARY OF FINDINGS - Attach site ma	an showing sampling point l	ocations transects import	tant features etc
Hydrophytic Vegetation Present?	No	Is the Sampled Area	tanti reatares, etc.

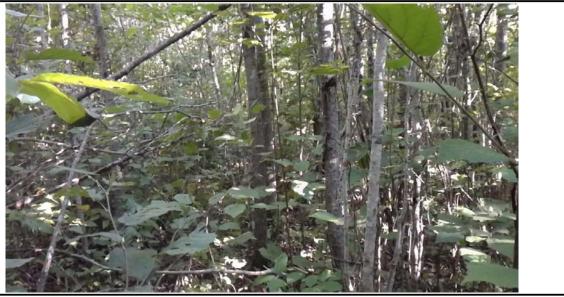
Site Photograph 1 Sampling Point: u-50n26w6-a12

AND THE RESERVE TO TH					
Latitude:	46.8332818150956	Cowardin Classification:				
Longitude:	-93.6813131813832	Circular 39:				
Direction: North		Eggers & Reed:				
Remarks:

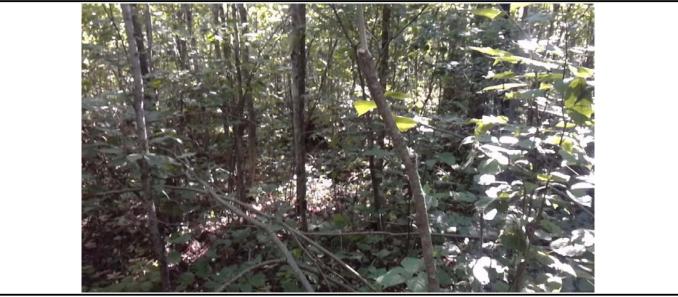
Site Photograph 2 Sampling Point: u-50n26w6-a12

Latitude:	46.8332804320816	Cowardin Classification:			
Longitude:	-93.6813131813832	Circular 39:			
Direction: East	<u> </u>	Eggers & Reed:			
Remarks:
