WETLAND DETERMINATION DATA FORM - North Central and Northeast Region

Project/Site: SPP	City/County: Aitkin		Sampling Date: 2016-08-19		
Applicant/Owner: Enbridge		State: Minnesota	Sampling Point: u-50n26w6-a16		
Investigator(s): ZCW, MGH	Section, Tow	rnship, Range: S18, T50N, F	 R26W		
Landform (hillslope, terrace, etc.): Rise		Local Relief (concave,			
Subregion (LRR or MLRA):		•	Longitude: -93.67891302 Datum: NAD83	_	
Soil Map Unit Name: 533			NWI Classification: N/A		
Are climatic/hydrologic conditions on t	the site typical for this time of	vear? (if no explain in Rem	-	_	
			· · · · · · · · · · · · · · · · · · ·		
Are Vegetation No_, Soil No_, or H	lydrology No significantly dis	sturbed? Are "Normal Circ	cumstances" present? Yes		
Are Vegetation No , Soil No , or Hydrology No naturally problematic? (If needed, explain any answers in Remarks)					
SUMMARY OF FINDINGS - Attach s			portant features, etc.	_	
Hydrophytic Vegetation Present?	No No	Is the Sampled Area

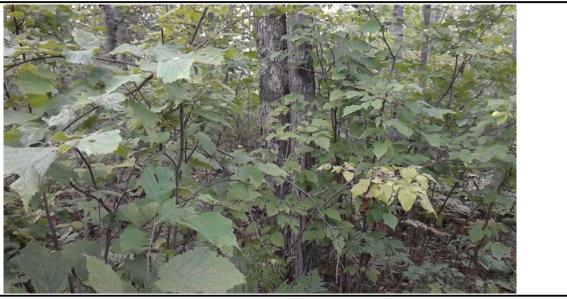
Site Photograph 1 Sampling Point: u-50n26w6-a16

Latitude:	46.8250059010897			Cowardin Classification:	
Longitude:	-93.678952502174			Circular 39:	
Direction: North Eggers & Reed:					
Remarks:

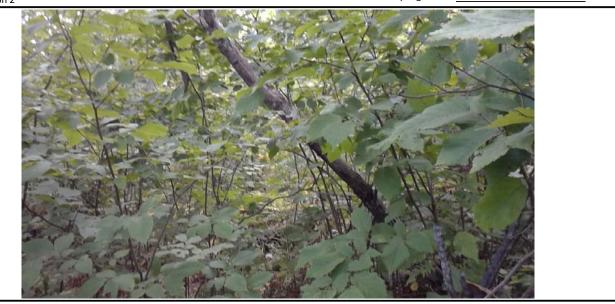
Site Photograph 2 Sampling Point: u-50n26w6-a16

APPLIES TO THE STATE OF THE STA		
Latitude: 46.8250034284283	Cowardin Classification:	
Longitude: -93.6789732892939	Circular 39:	
Direction: West	Eggers & Reed:	
Remarks:
