WETLAND DETERMINATION DATA FORM - North Central and Northeast Region

Project/Site: SPP	City/County: Ait	City/County: Aitkin		Sampling Date: 2016-08-09	
Applicant/Owner: Enbridge		State: Minnesota	Samplin	g Point: <u>u-50n26w6-a3</u>	
Investigator(s): ZCW, MGH	Section, T	ownship, Range: S, T50N, R	k26W		
Landform (hillslope, terrace, etc.): Ris	se	Local Relief (concav	ve, convex, none): VL	Slope (%): <u>3-7%</u>	
Subregion (LRR or MLRA):	Latit	ude: 46.8537021009	Longitude: -93.67805840	Datum: NAD83	
Soil Map Unit Name: 504B			NWI Clas	ssification: N/A	
Are climatic/hydrologic conditions or	Are climatic/hydrologic conditions on the site typical for this time of year? (if no, explain in Remarks):				
Analyanahatian No. Cail No.	. Hadaalaaa Noo alaadii aaad				
Are Vegetation No_, Soil No, or	Hydrology No Significantly	disturbed? Are Normai Ci	rcumstances present? 1es_		
Are Vegetation No_, Soil No_, or H	ydrology No naturally prob	olematic? (If needed, expla	in any answers in Remarks)

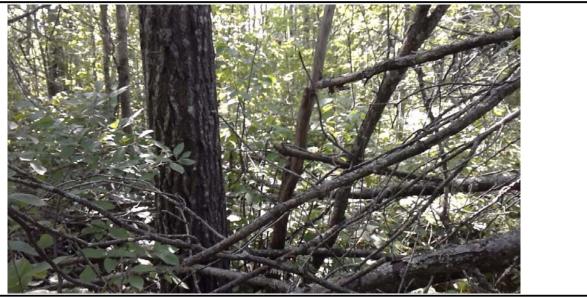
Site Photograph 1 Sampling Point: u-50n26w6-a3

Latitude:	46.8537046993588	Cowardin Classification:		
Longitude:	-93.6781505216785	Circular 39:		
Direction: Nor	thwest	Eggers & Reed:		
Remarks:				
Upland
