## WETLAND DETERMINATION DATA FORM - North Central and Northeast Region

Project/Site: SPP	City/County: Aitki	n	Sampling Date: 2016-08-09				
Applicant/Owner: Enbridge		State: Minnesota	Sampling Point:	u-50n26w6-a4			
Investigator(s): ZCW, MGH	Section, To	wnship, Range: S6, T50N, R					
Landform (hillslope, terrace, etc.): Ris		Local Relief (concave		Slope (%): 3-7%			
Subregion (LRR or MLRA):		•	· <del></del>	um: NAD83			
Soil Map Unit Name: 292			NWI Classification				
	the site typical for this time of	f vear? (if no explain in Rer	<del></del>	No			
Are Vegetation No_, Soil No_, or	Hydrology No significantly of	disturbed? Are "Normal Cir	cumstances" present? Yes				
Are Vegetation No , Soil No , or H	ydrology No naturally proble	ematic? (If needed, explair	any answers in Remarks)				
CURANA DV OF FINIDINGS							
SUMMARY OF FINDINGS - Attach							
Hydrophytic Vegetation Present?	No No	Is the Sampled Area					
Hydric Soil Present?	No No	within a Wetland?	No No				
Wetland Hydrology Present?	No	If yes, optional Wetla	and Site ID:

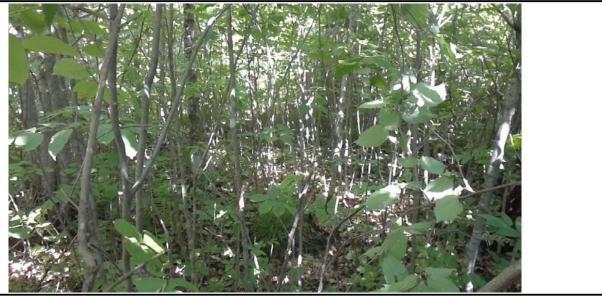
Site Photograph 1 Sampling Point: u-50n26w6-a4

In the second se	
Latitude:	46.8501855154027	Cowardin Classification:	
Longitude	: -93.6818760261812	Circular 39:	
Direction: Nor	rth	Eggers & Reed:	
Remarks:			
Upland			
1

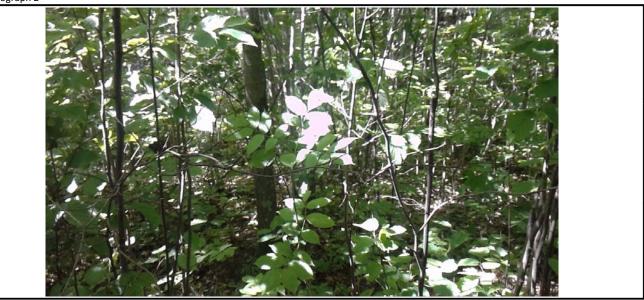
Site Photograph 2 Sampling Point: u-50n26w6-a4

Latitude: 46.8501852639456  Longitude: -93.6818761938193  Direction: West	Cowardin Classific	ation:
	Eggers & Reed:	
Remarks: Upland
